# ***PROCEEDINGS***

**OF THE MERCHANT MARINE COUNCIL**

**Vol. 21, No. 3**

**March 1964**

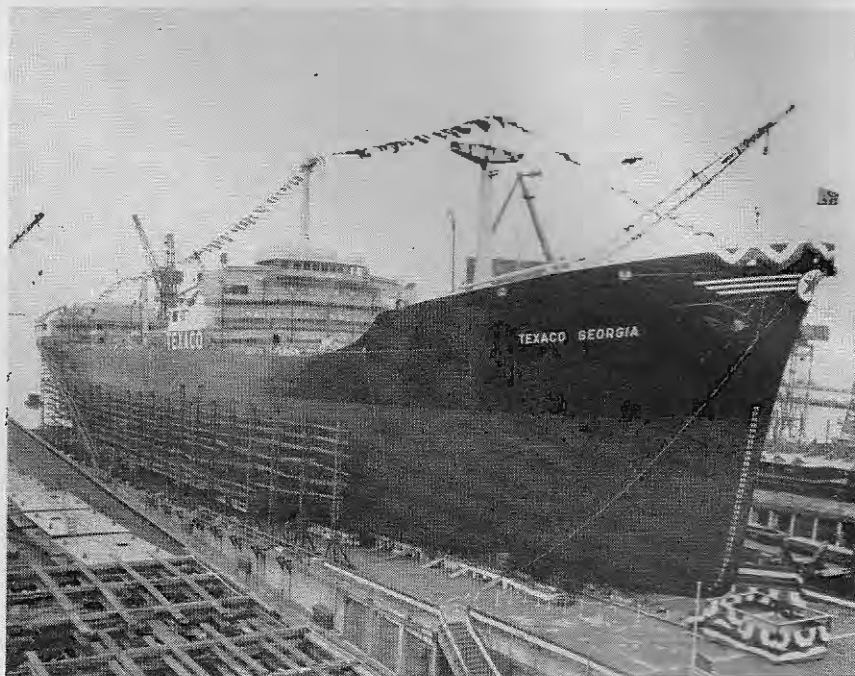
THE SS TEXACO GEORGIA, newest addition to the Texaco Fleet, is shown standing on the ways at Bethlehem Steel Company's Sparrows Point (Md.) Shipyard just prior to recent launching ceremonies. The 26,200-deadweight-ton vessel, third of five ships being built for Texaco by Bethlehem is about 604 feet long, has a breadth of 78 feet, a depth of about 44 feet and a loaded draft of some 34 feet. She has a liquid cargo capacity of more than 8,900,000 gallons and her dry cargo capacity is approximately 44,000 cubic feet.
