# Proceedings

of the Marine Safety Council

Vol. 39, No. 7

July 1982

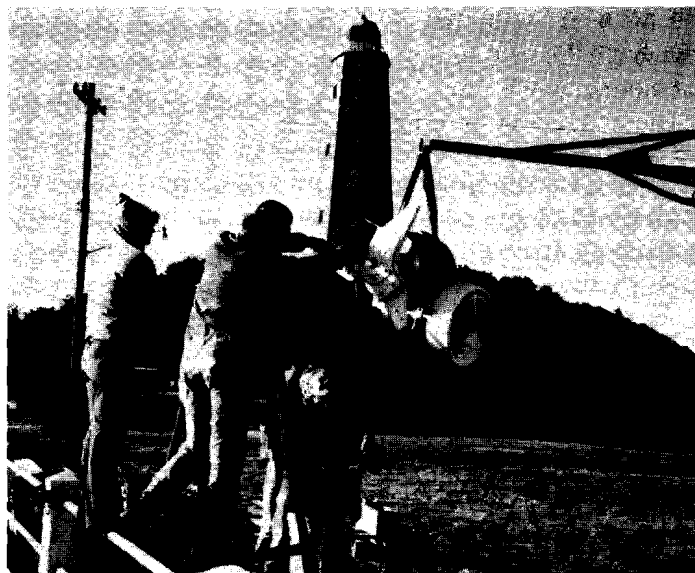
*The generator portion of the wind machine is hoisted to a mount prior to the machine's installation atop the 60-foot tower. In the background is the original Cape Henry lighthouse, now a historical monument.*

To begin Phase Two, the APL team first designed the wind machine test, then assembled the components at its facilities in Howard County, Maryland. The propeller blades and the generator were fitted to the tower's dimensions, and the initial conditions of the wind machine were carefully measured. Also being developed was the equipment that would load, control, and monitor the wind machine. The wind machine itself had been developed by North Wind Power Company for the Department of Energy, while APL had designed the test and built the ground equipment.

Erection of the wind machine at Cape Henry took place last October. A month earlier, the APL group had supervised the pouring of a six-foot deep concrete platform. Such a depth was considered necessary to keep the tower stable

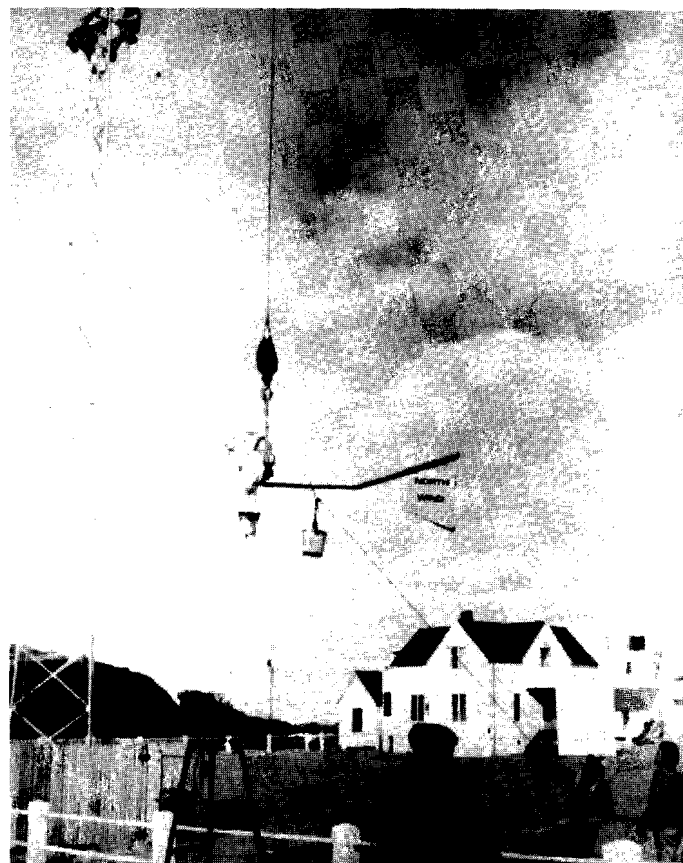
*Riggers atop the 60-foot tower prepare to install the wind machine being lifted by crane. The attached bucket was used to lower the tools or other equipment they needed.*
