Proceedings

of the Marine Safety Council

Vol. 40, No. 8
September 1983

The Case of the Missing Freon-12

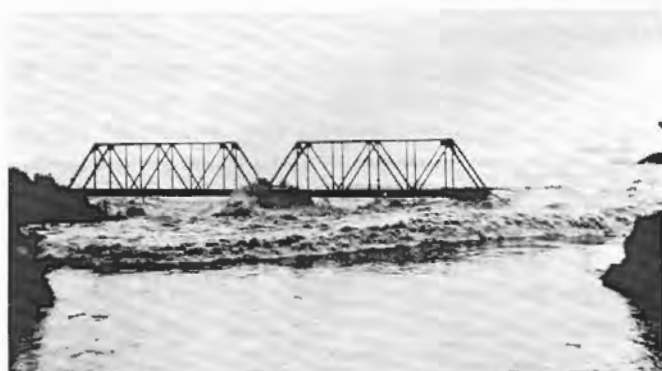
The bore, or advancing wave crest, of a tsunami spawned by an earthquake in the Aleutian Islands passes a damaged railroad bridge over the Wailuka River (Hawaii Island, Hawaii, April 1946). Photo courtesy of the University of California at Berkeley

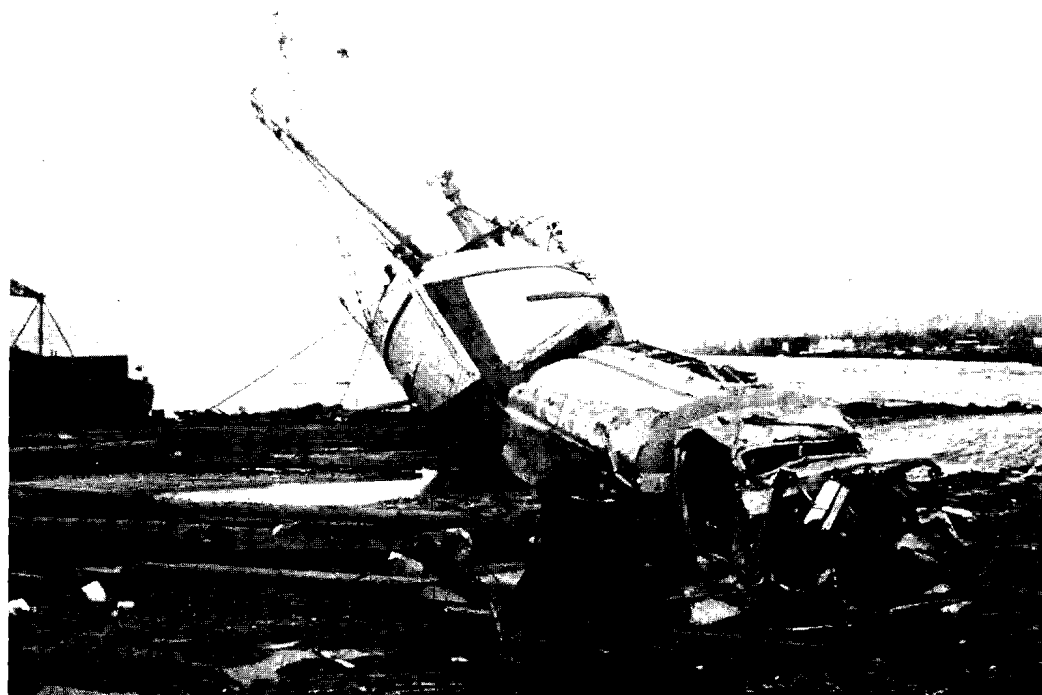
The tsunami that left a Texaco chemical truck demolished and the CELTIC beached swept into Resurrection Bay, Alaska, in March 1964. Photo courtesy of the U.S. Department of the Interior

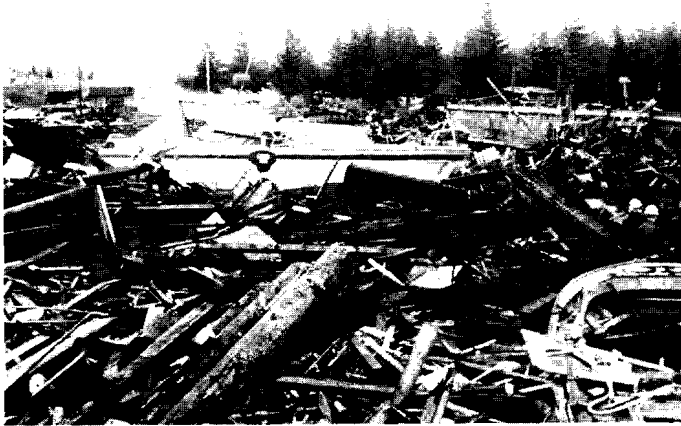
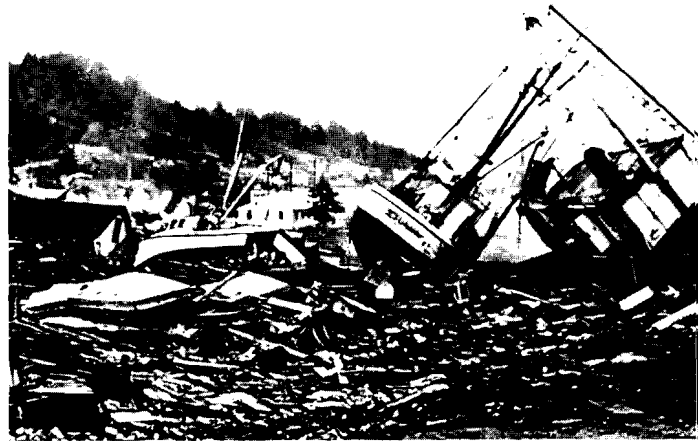
The damage done to the Seward, Alaska, port facilities, like that done to the Texaco truck on the preceding page, was caused by a tsunami generated by an earthquake in Anchorage. Photos courtesy of (left) the U.S. Department of the Interior and (right) NOAA/EDIS

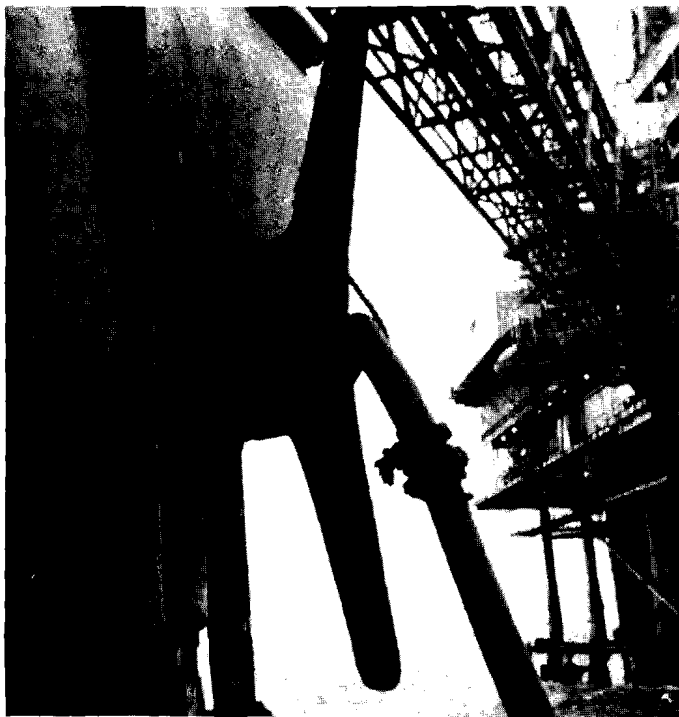
Roustabouts hung a replacement mooring line for the OSV over the upper horn of this cleat; it slipped off in the rough seas.

them reported that the port mooring line was parting at the bitt. This information was relayed to the platform. When rig personnel responded that they had no additional mooring lines, a line was passed from the vessel to be secured to the platform.
