# Proceedings

*of the Marine Safety Council*

Vol. 44, No. 5

May 1987

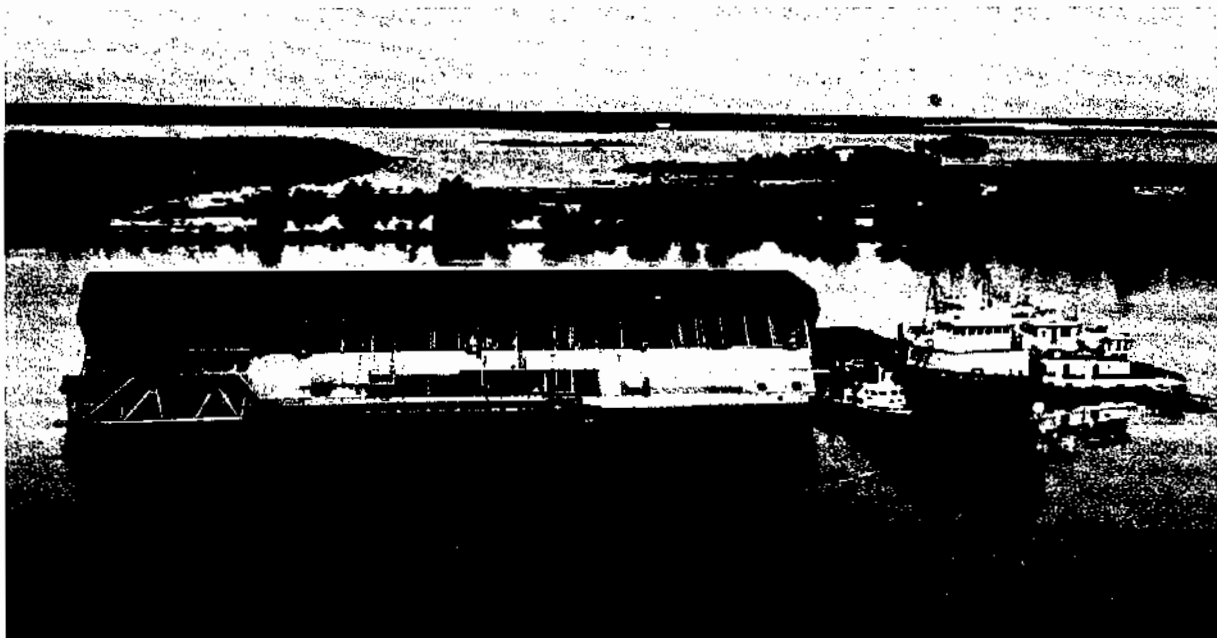
The capsized *Tonkawa* on May 22, 1985. (Official U.S. Coast Guard photo)
