Proceedings

of the Marine Safety Council

Vol. 44, No. 8

September 1987

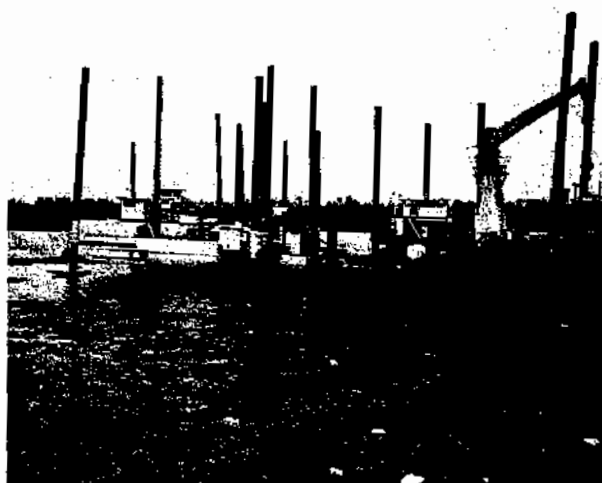
Fleet of liftboats alongside a Mississippi River facility. (Photo courtesy of the author)
