Proceedings

of the Marine Safety Council

August-September 1988

Preparing for a Chemical Emergency: The Morgan City Case

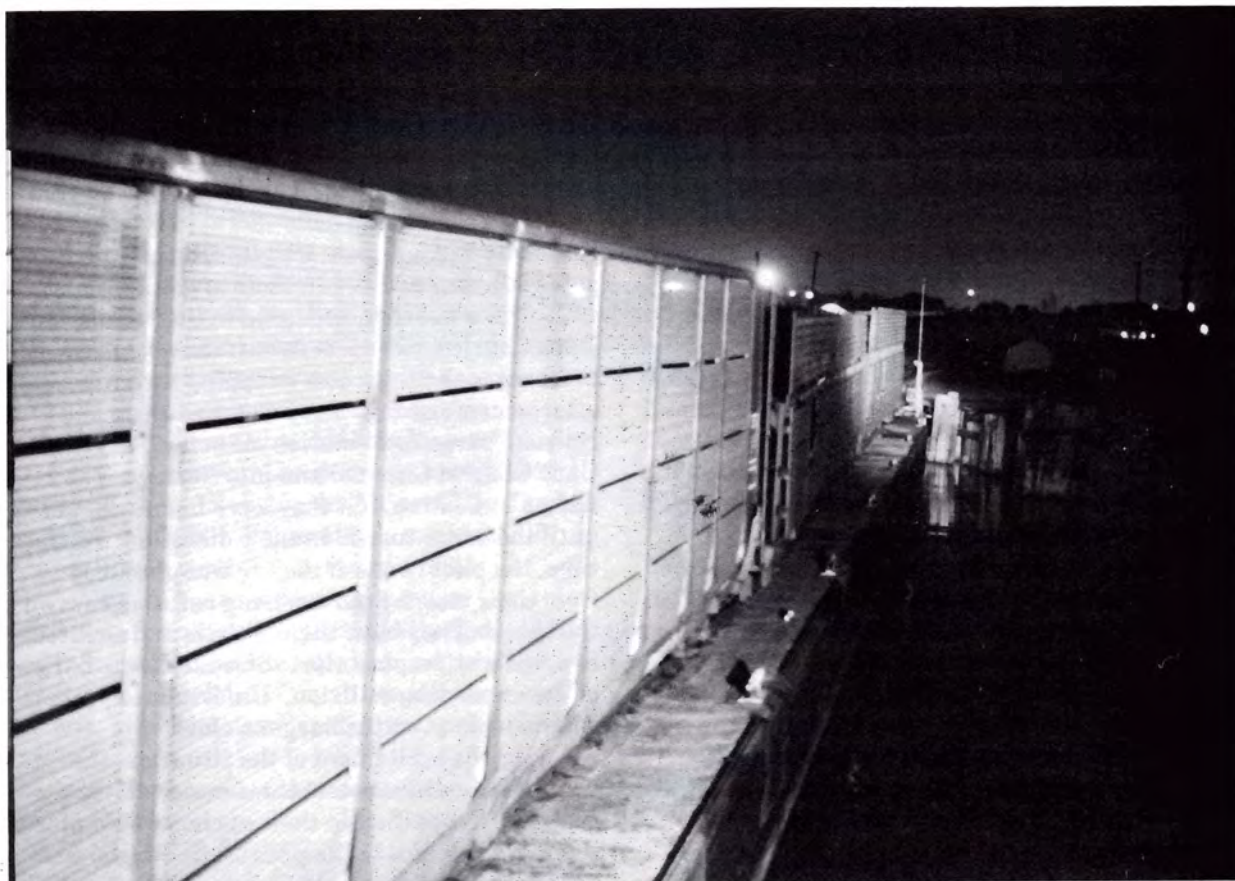
This photo was taken from the pilot house of the tug after it arrived in Little Creek, Virginia. (Photo by LTJG Don Noviello)

Neither operator had lookouts at the time of the collisions, and both were prevented from seeing anything to the port side of their vessel by the tall railroad cars on the barge. In effect, their whole port side was blind. Both men contended that they were capable of acting as lookout and operator from the pilot house and hence needed no lookout. They added that they had made this voyage many times before, transporting railroad cars between Virginia's
