# Proceedings

*of the Marine Safety Council*

March-April 1990

United States  
Coast Guard

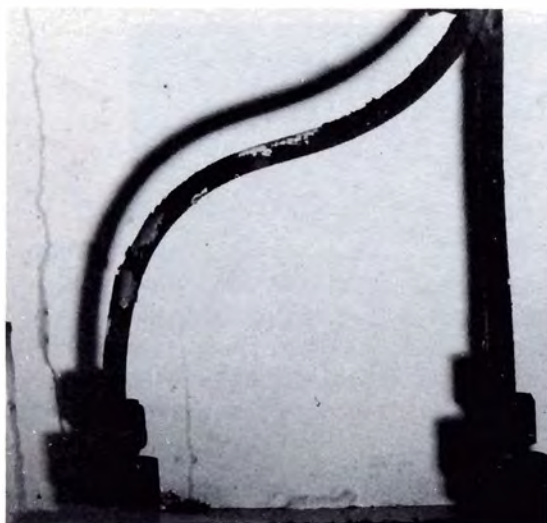
*The blackened condition of brass and copper sewage treatment unit components indicate the presence of hydrogen sulfide.*

The proximate cause of this casualty was the lack of knowledge on the part of the vessel's owner/operating company and crew concerning the lethal gases generated by decomposing organic matter in the sewage treatment units. Furthermore, the crew did not recognize the telltale odor of rotten eggs nor the blackened brass and copper fittings which indicate the presence of hydrogen sulfide.

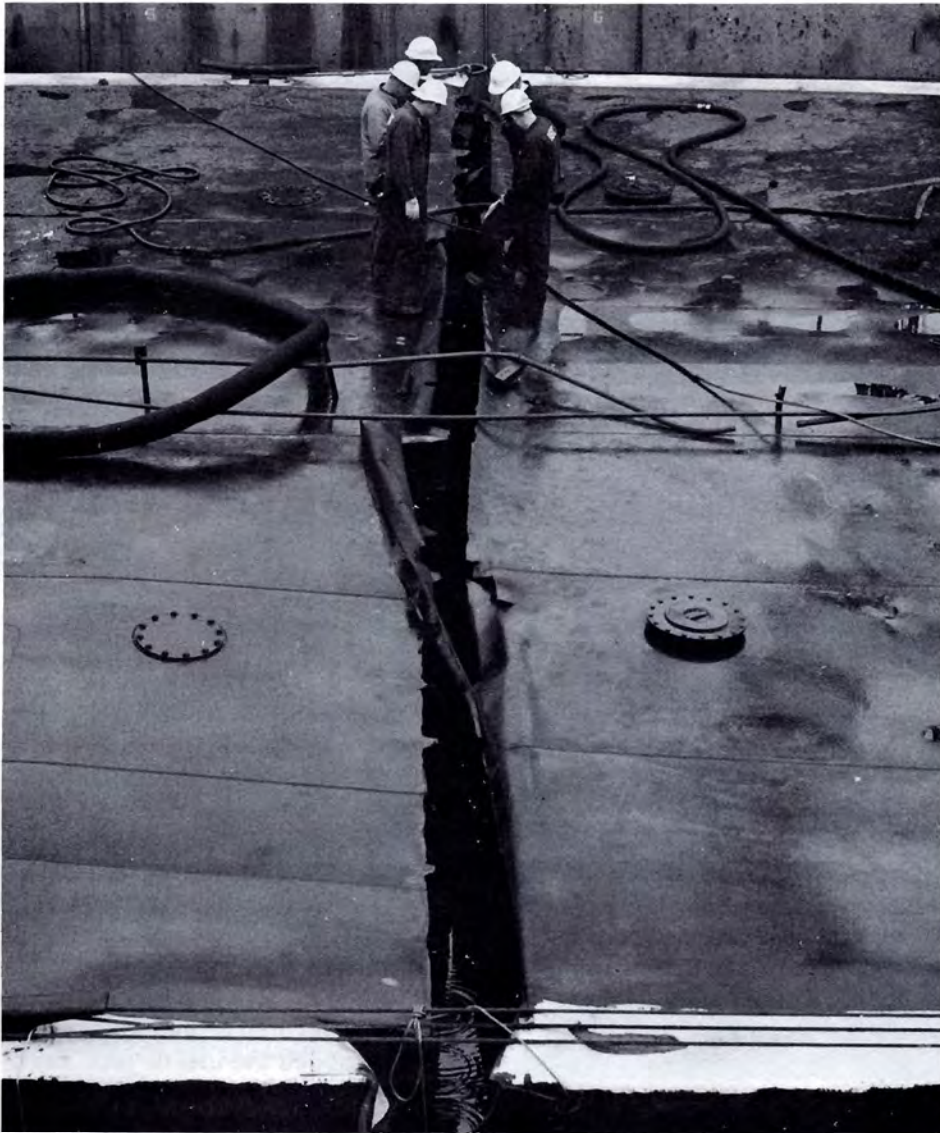
*Inspectors survey damage to the deck of a tank barge which resulted from structural damage.*

Older barges are susceptible to fatigue failure, which is characterized by groups of small cracks, aggravated by corrosion. Mid-plate cracks originating from corrosion pits or detail notches may be fatigue cracks. Inspectors have been advised to be extremely careful in evaluating such cracks.

cargo and maintenance. It is recommended that a structural analysis be conducted by the American Bureau of Shipping (or equivalent organization) if mid-section fatigue cracks are detected.

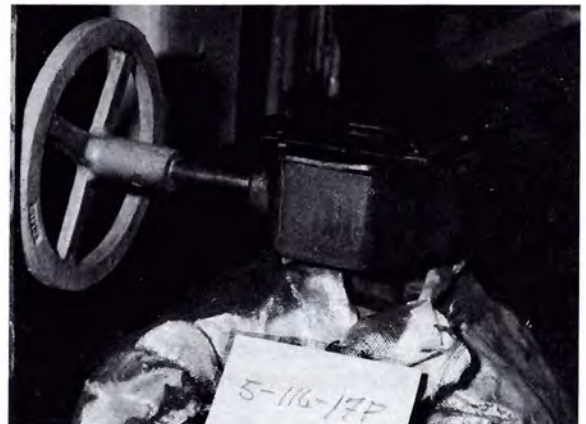
*The removal of this cracked gearbox assembly caused the fuel leak that started the fire.*

The ship was headed home after a five-month deployment. An oil king (crewmember responsible for oil stowage and transfer) was transferring fuel to correct a minor list when he tried to operate a butterfly valve located in the fireroom in the fuel-oil transfer system. The operator gearbox on top of the valve cracked, and a portion of the gearbox casing and valve handwheel broke off.

The oil king removed the gearbox and sent it to the machinery repair shop. He did not tag out the valve or place it in an out-of-commission status. He simply took out the bolts that held the gearbox in place and left the valve stem exposed.

60 psi. As the oil king topped off one fuel tank, he momentarily shut one valve prior to opening another. This caused fuel pressure to jump to 70 psi, which blew the butterfly valve stem from its seat and allowed a high-pressure geyser of fuel to shoot into the overhead of the fireroom and ricochet onto the back and top of No. 3 boiler.

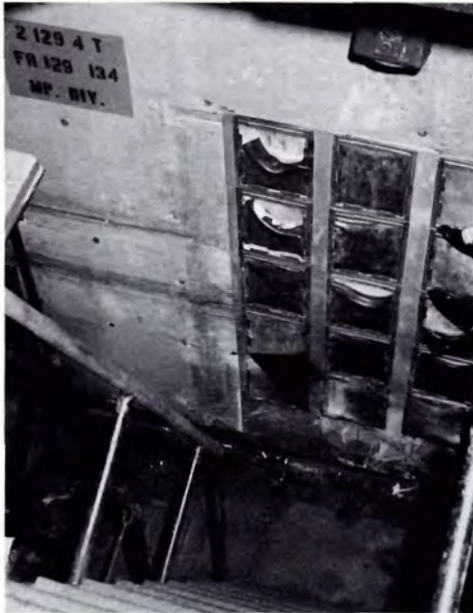
*Intense heat damage to the main escape route from the boilerroom.*
