PROCEEDINGS

of the Marine Safety Council

Small Passenger Vessels

January – March 2002

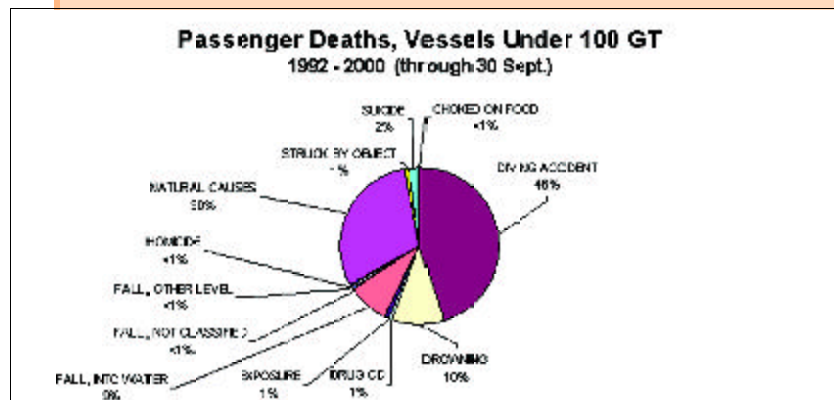
Deaths by Accident Type

One item reported by Coast Guard investigators describes the nature or type of accident that resulted in a passenger death. This information may be useful in explaining the increase in fatalities in recent years. The accident types are summarized in the graph in the opposite column.

The graph indicates that a large portion of the passenger deaths resulted from causes not directly related to the vessel. For example, deaths from natural causes include heart at-

tacks and strokes, which could have occurred at any time or place. Similarly, diving deaths typically result from errors made by the diver, such as ascending too quickly, entanglement in kelp, getting lost in a wreck, and diving equipment failures. Also, the investigations revealed that many of the diver deaths were linked to pre-existing medical conditions. Finally, an examination of the 25 reported drowning deaths showed that six of the deaths occurred while the passengers engaged in swimming or snorkeling. In fact, 75.2 percent of all passenger fatalities resulted from diving accidents and natural causes. Collectively, all non-vessel accident types account for 81.3 percent, or 200 of the 246 passenger deaths, summarized as follows:

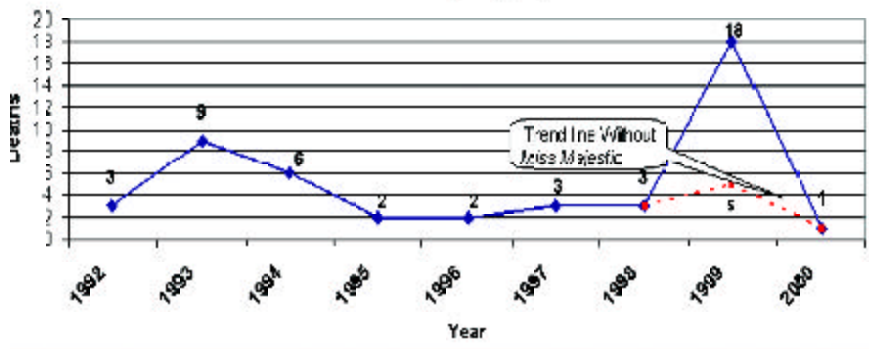
**"Vessel-Related" Passenger Deaths
1992 - 2000 (Partial year)**

The subset of 46 vessel-related fatalities occurred in 29 incidents, which is approximately five deaths or three separate incidents per year. When other factors are considered, such as the specific industry segment of the involved vessels (e.g., party fishing, excursion, diving, etc.), or the nature of the fatality, these cases may be truly rare occurrences. However, as a group, the data may reveal some general themes or patterns.

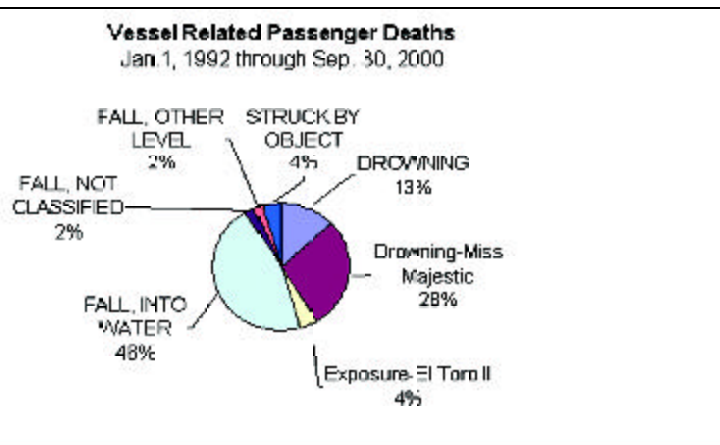
Vessel-Related Deaths, by Accident Type

A summary of vessel-related fatalities is shown at right. The graph shows that most of the deaths, 40 of 46, or 86.9 percent, resulted from

At first, the ferry casualties might appear as an area of concern. However, the incidents occurred during a period of 7.5 years. In fact, three of the four cases occurred in 1994 and earlier. Intuitively, one knows that the potential for similar casualties exists, given the number of ferries in service, their size, and the number of vehicles carried. However, the data does not suggest anything other than random occurrences.

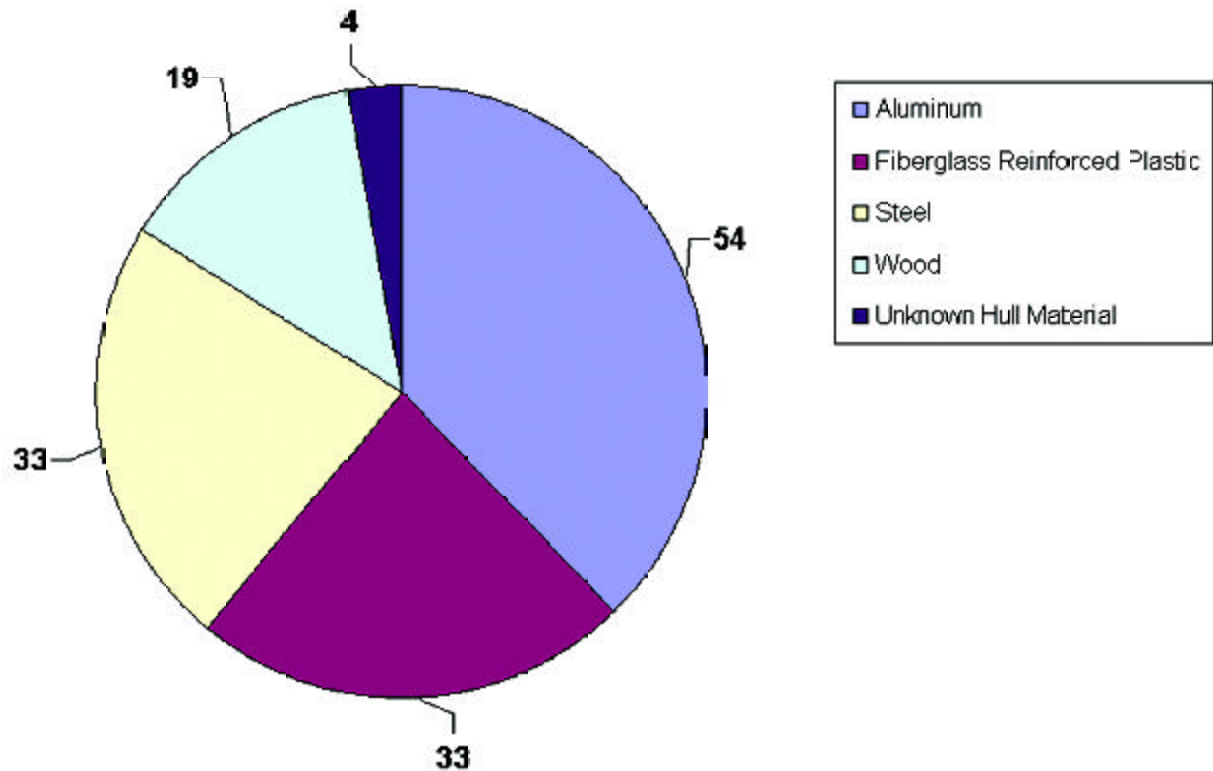
Fires On U.S. Flagged, USCG Inspected Passenger Vessels Under 100 Gross Tons By Vessel Hull Material
 (from 22 January 1992 to 05 December 2000)

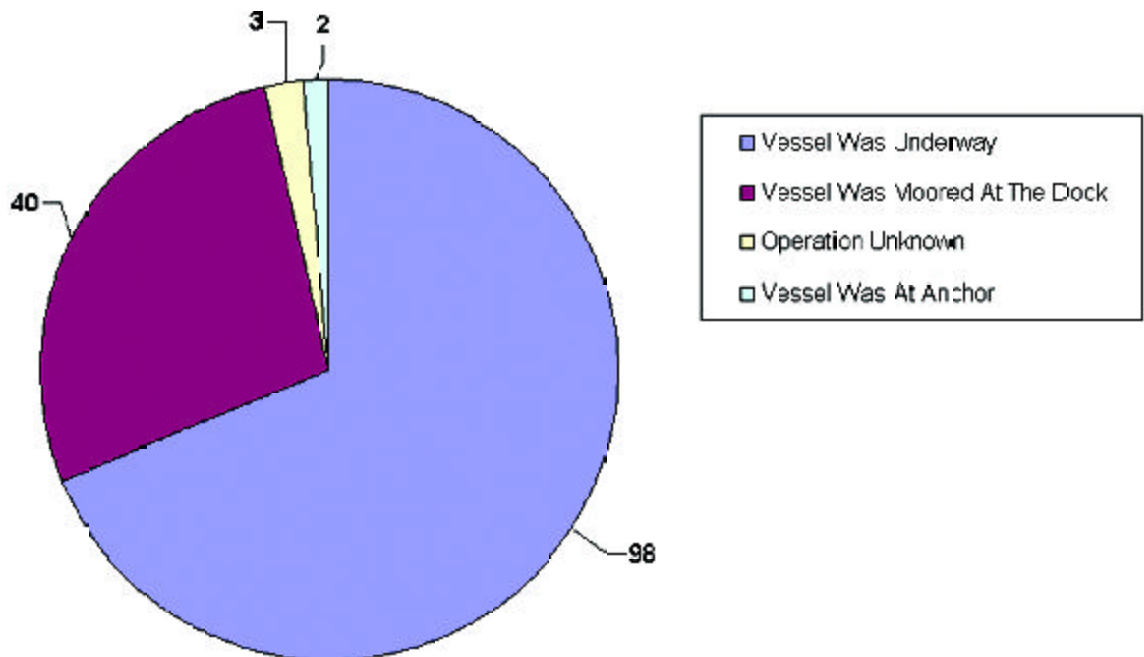
Fires On U.S. Flagged, USCG Inspected Passenger Vessels Under 100 Gross Tons By Vessel Operation At The Time Of The Casualty
 (from 22 January 1992 to 05 December 2000)

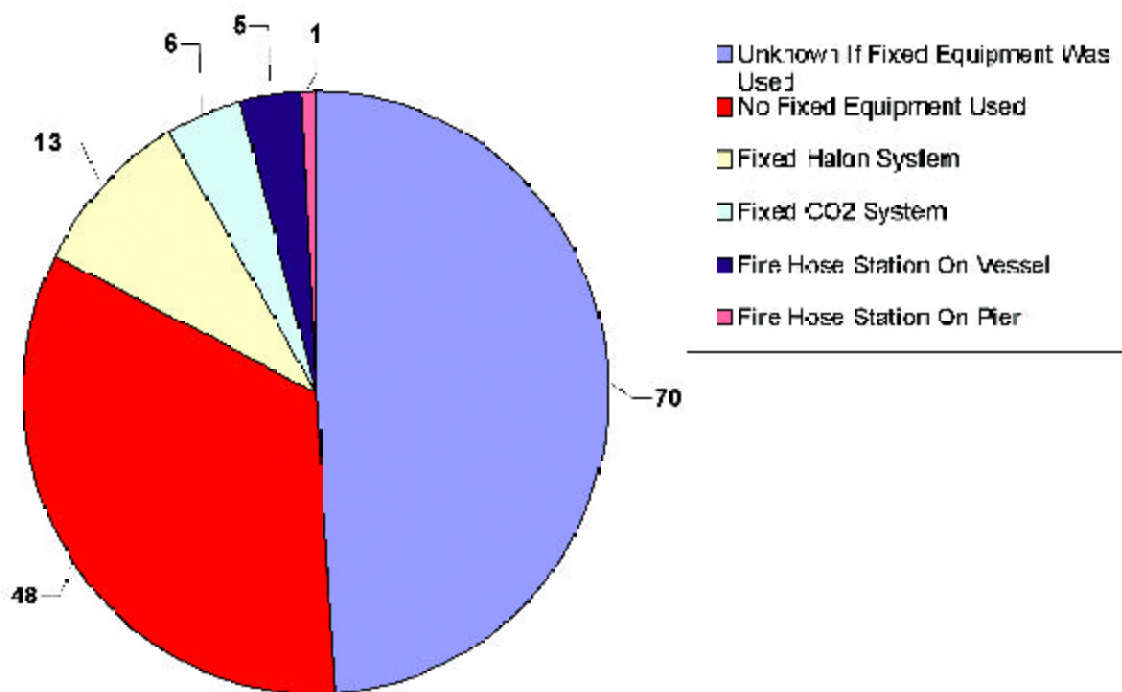
**Fires On U.S. Flagged, USCG Inspected Passenger Vessels Under 100 Gross Tons By Fixed Equipment Used To Fight The Fire
(from 22 January 1992 to 05 December 2000)**

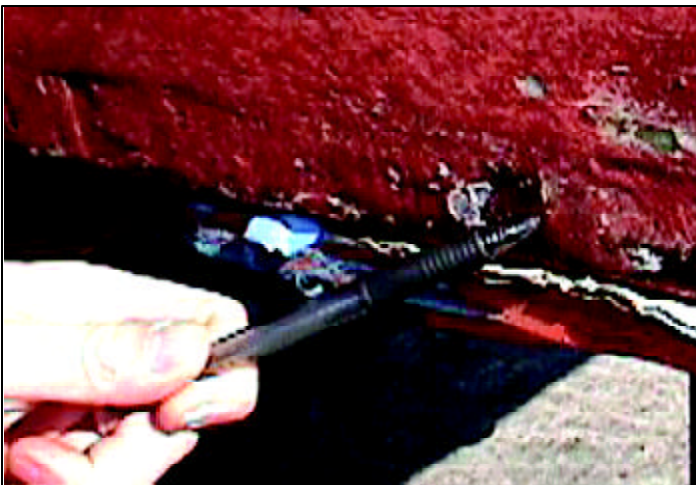
A marine inspector points out the port aft corner of the *Elaine B II*, which indicates the obvious cross-planked (dead rise) construction of the vessel.

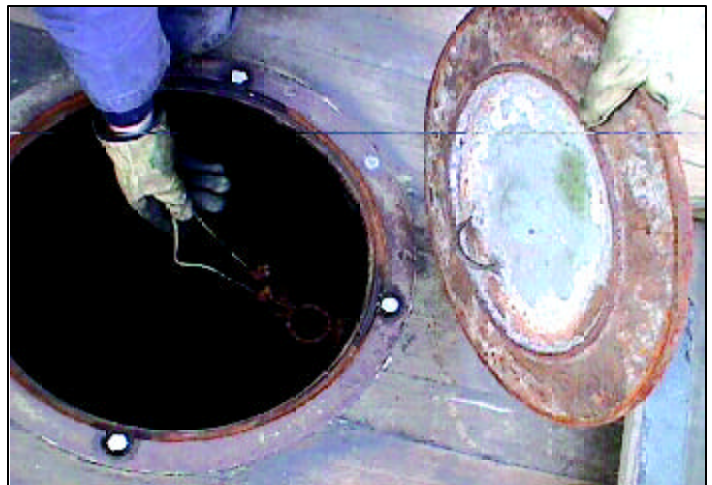
Marine inspectors enter lazarette to examine steering equipment, through hull fittings and planks. *Elaine B II*'s exterior hatch covers were required to be properly secured to the vessel.

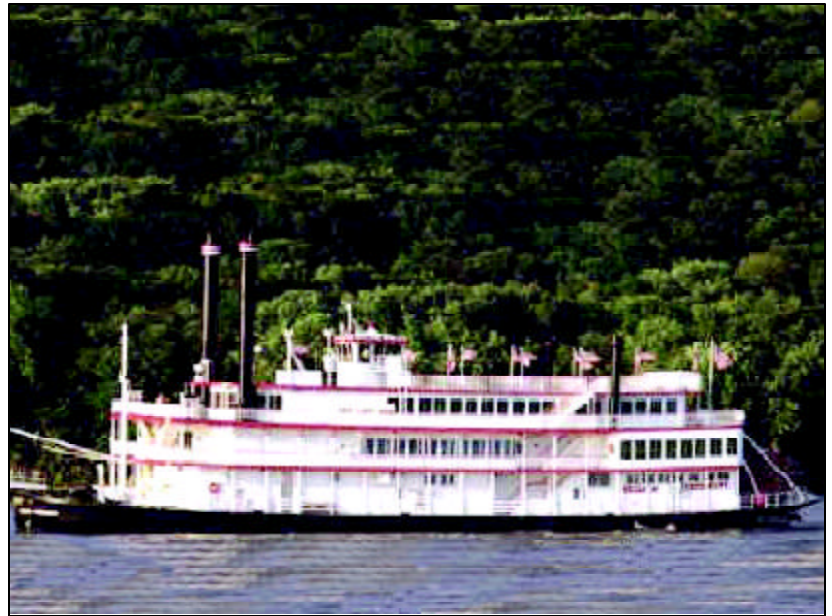
The M/V *Belle of Cincinnati*, owned by Ohio River-based BB Riverboats. Photo courtesy BB Riverboats.

In one workshop demonstration of the PVA Risk Guide, BB Riverboats (on the Ohio River) brought forth its concerns with passenger movement on its 100-ft. paddle wheel riverboat. The problem was slips, trips and falls surrounding a passenger stairway. Bringing together relevant members (including the company, Coast Guard, and local waterways personnel), the group created a list of potential hazards. After identifying the initial list of hazards, they paired them down into those most serious. Two of the main hazards included passengers tripping on the stairs and persons overboard. This allowed the group to discuss various solutions and their accompanying benefits and costs, in essence ranking the

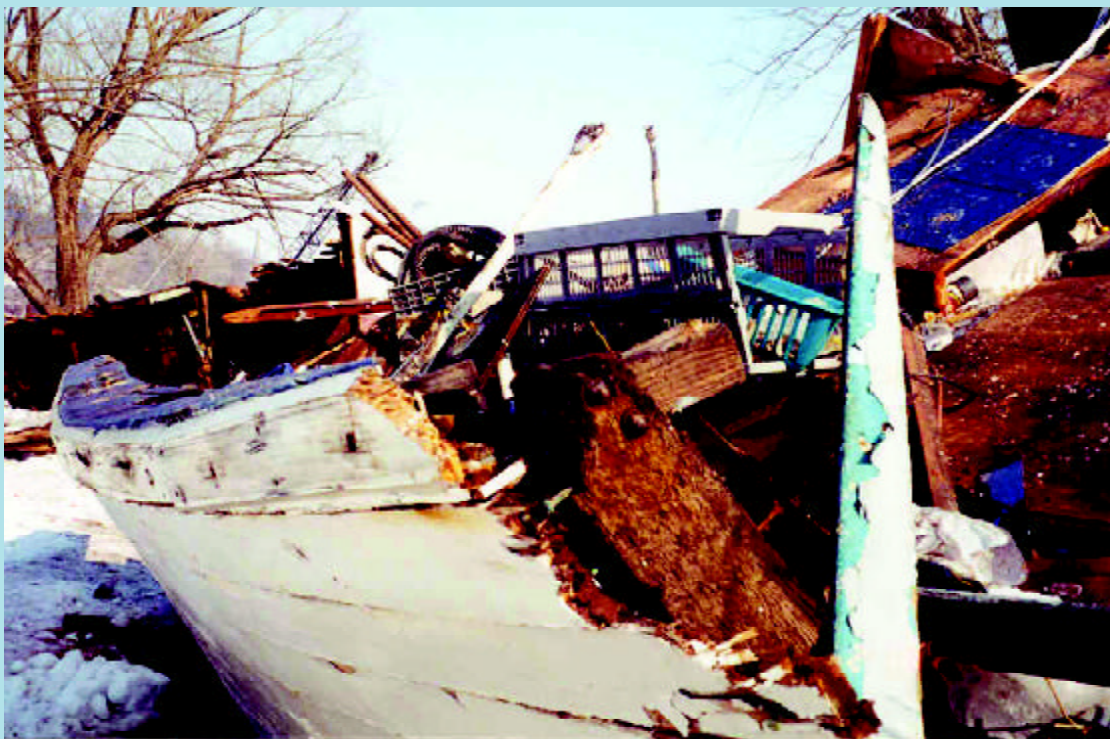
USCG photo courtesy U.S. Coast Guard Activities New York. The sunken party cruise vessel *Crescent* in Roundabout Creek in Connelly, NY. An investigation determined that the vessel took on water due to deteriorated fasteners throughout the wood hull of the vessel. Additionally, there was a putt over a seam on the hull that was cracked.

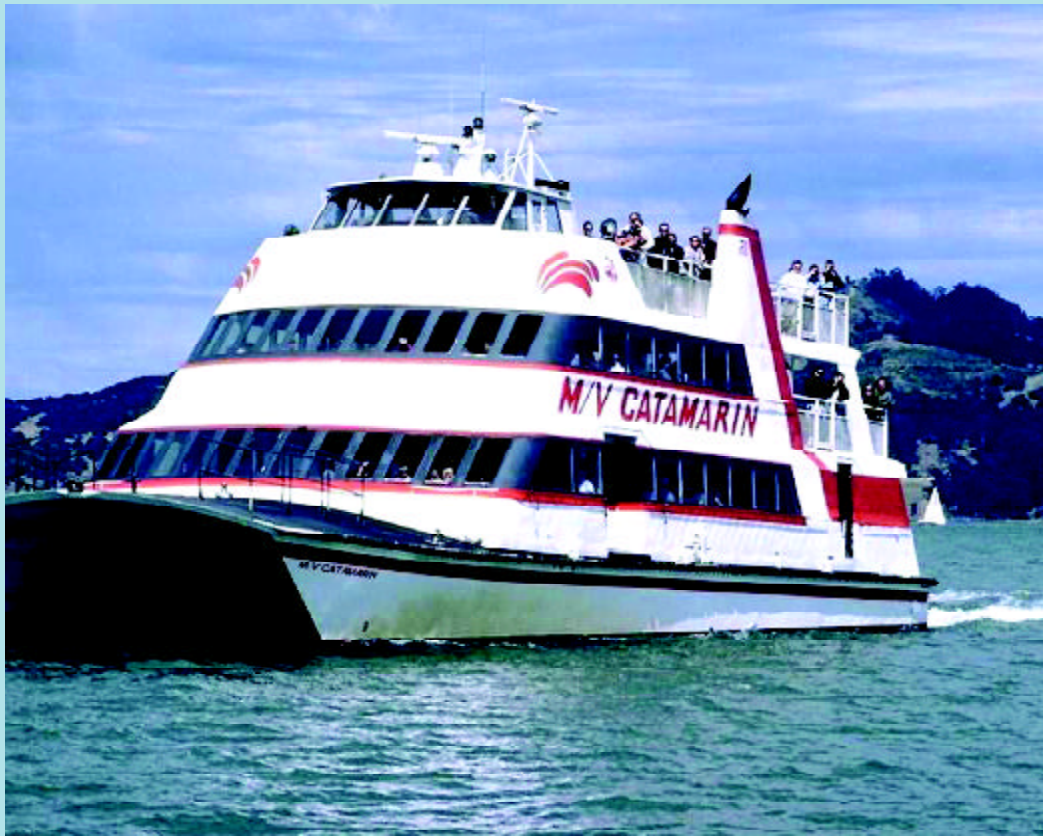
A multi-deck passenger ferry with a catamaran-type hull.

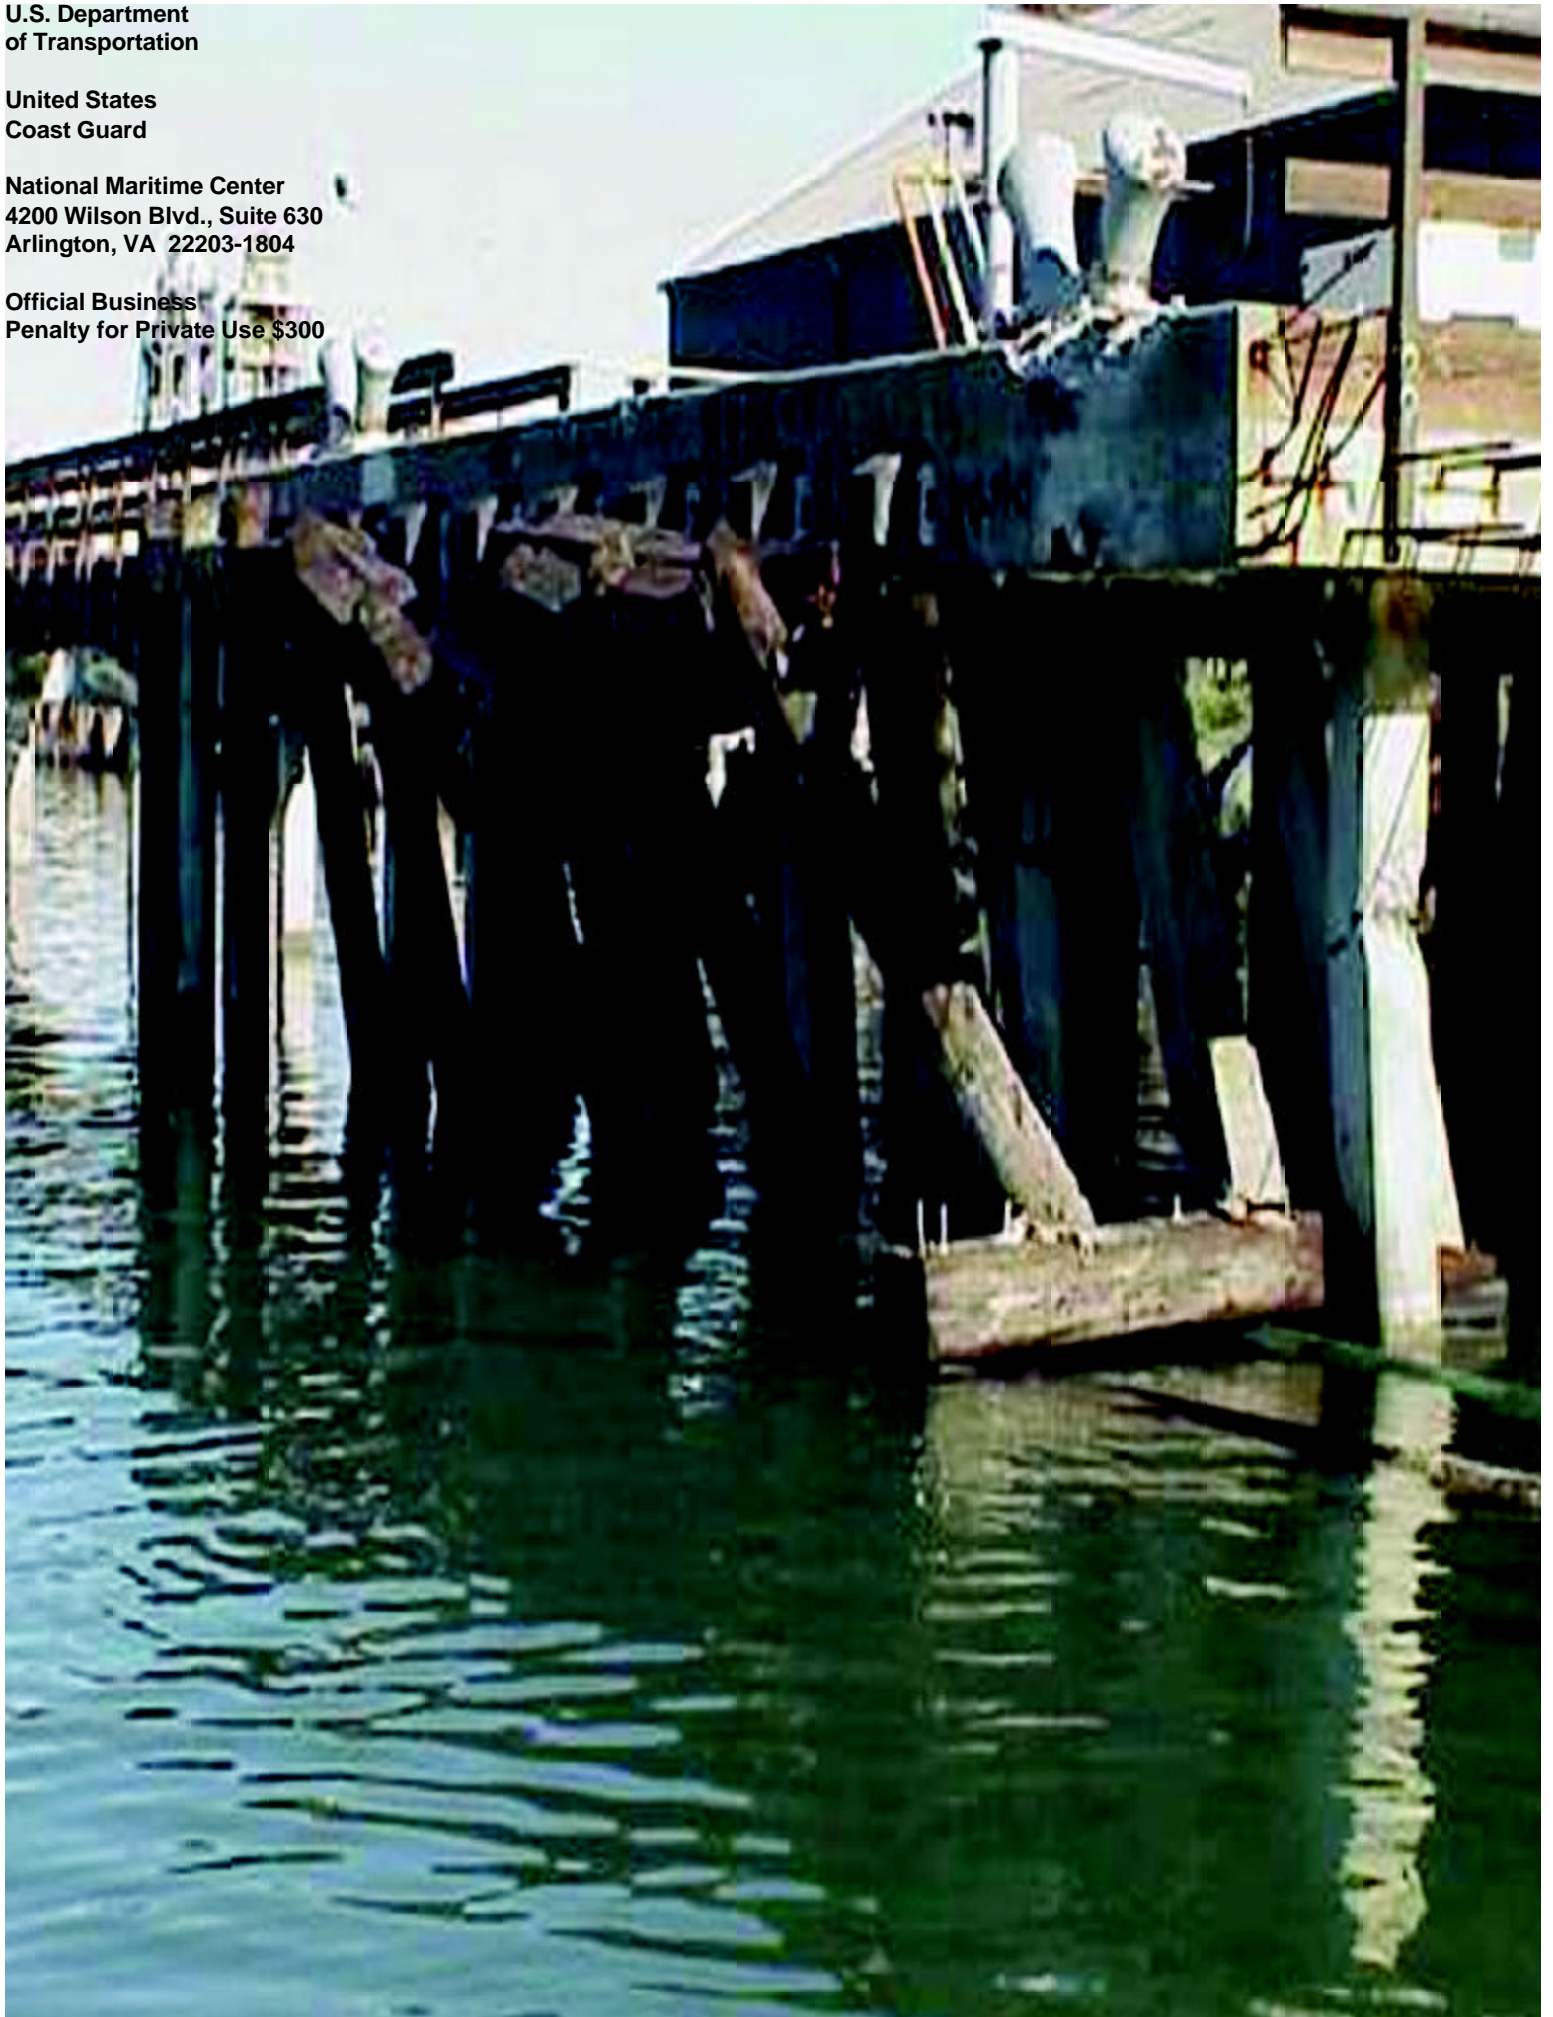
M/V Ranger, a whale-watching boat, spies a whale. BACK PAGE: Damage is shown to Terminal 2 in the Port of Richmond, Calif., which was damaged by the *M/V Nita M* when it was hit. Pier-side and underwater survey indicated that there are six cracked cement pilings and 50 feet of wooden fenders sheared near the two bollards used mainly for spring lines. The *Nita M* has been inspected by the vessel's classification society surveyor and found to have sustained an indentation on the stem that can be repaired during a dry-dock period. USCG photo.
