# **UNITED STATES COAST GUARD**

**REPORT OF THE INVESTIGATION  
INTO THE  
CAPSIZING OF THE BARGE AMBITION (CG 1647791)  
IN THE GULF OF MEXICO ON  
JUNE 15, 2022**

**CAPSIZING OF THE UNINSPECTED CRANE BARGE AMBITION (CG# CG1647791)  
AND SUBSEQUENT DISCHARGE OF OIL WHILE BEING TOWED BY THE  
INSPECTED TOWING VESSEL KAREN KOBY (O.N. 1230122) IN THE GULF OF  
AMERICA 15 NAUTICAL MILES SOUTH OF FRESHWATER BAYOU, LOUISIANA  
ON JUNE 15, 2022**

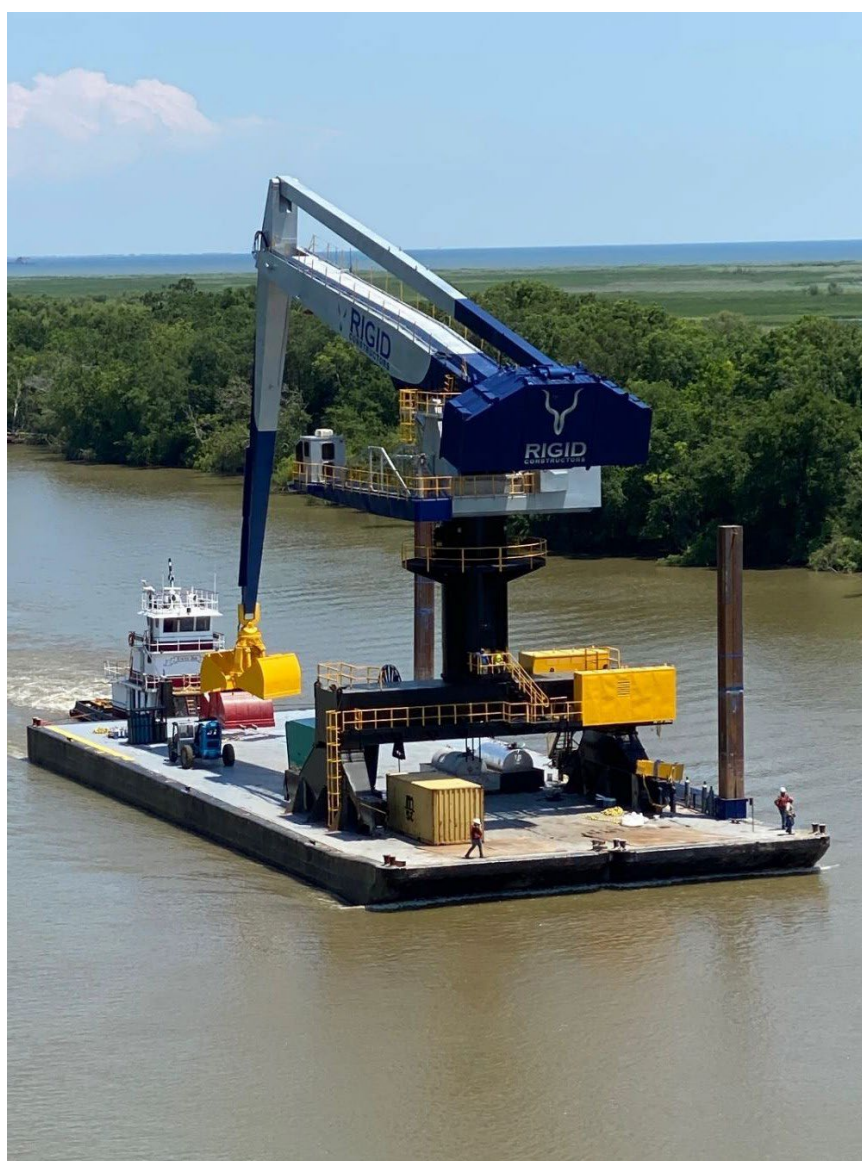
Figure 1. Photograph of AMBITION provided by [REDACTED], Rigid Construction. Date taken: unknown.

Official Name:	AMBITION
Identification Number:	CG1647791
Flag:	United States
Vessel Class/Type/Sub-Type	Equilibrium Crane Barge
Naval Architect Survey:	2020
Gross Tonnage:	Not Available
Length:	195 Feet
Beam/Width:	70 Feet
Main/Primary Propulsion:	None
Owner:	Rigid Constructors LLC Breux Bridge, LA
Operator:	Rigid Constructors LLC Breux Bridge, LA

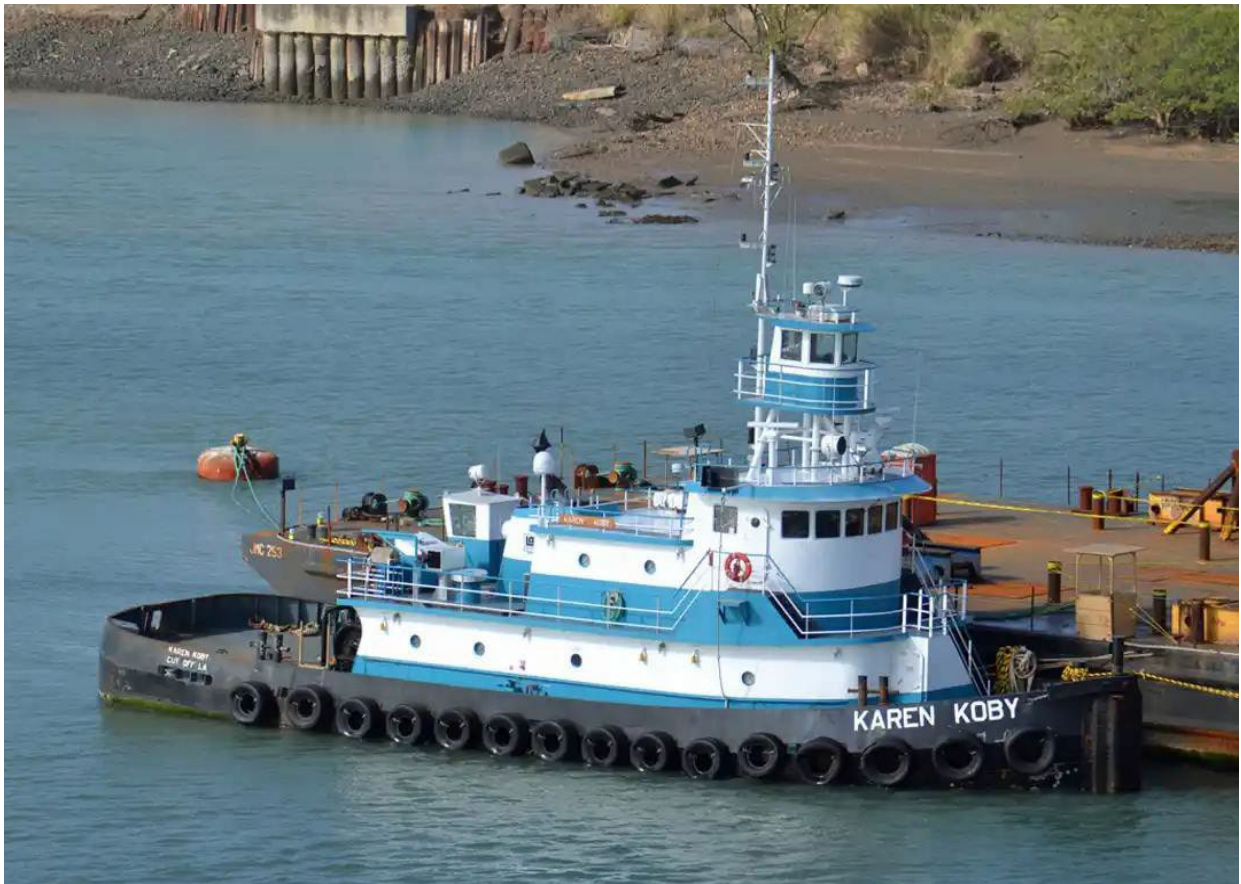
Figure 2. Photograph of KAREN KOBY provided by Shipspotting.com. Date taken: unknown.

Official Name:	KAREN KOBY
Identification Number:	1230122
Flag:	United States
Vessel Class/Type/Sub-Type	Towing Vessel
Year Built:	2010
Gross Tonnage:	278 GT ITC
Length:	94.4 Feet
Main/Primary Propulsion:	Diesel Reduction 2700hp
Owner:	LA Carriers LLC Larose, LA
Operator:	LA Carriers LLC Larose, LA
