UNITED STATES COAST GUARD

REPORT OF THE INVESTIGATION INTO THE SINKING AND LOSS OF LIFE ON THE RECREATIONAL VESSEL (LA-8245-FZ) IN THE GULF OF MEXICO ON AUGUST 23, 2024

**SINKING OF THE RECREATIONAL VESSEL LA8245FZ AND SUBSEQUENT LOSS
OF ONE LIFE IN THE GULF OF AMERICA, APPROXIMATELY 7.5 NAUTICAL
MILES SOUTH OF VERMILION BAY, LOUISIANA ON AUGUST 23, 2024**

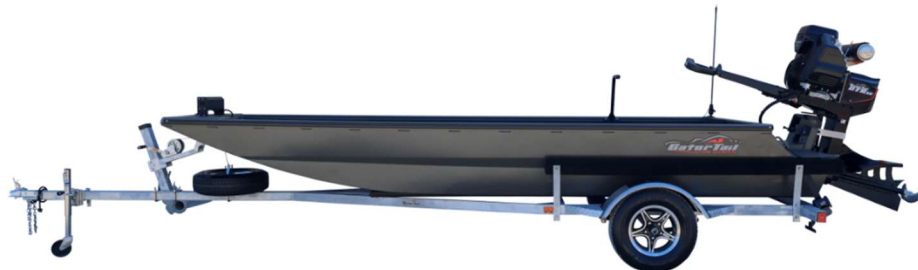
Figure 1. Picture of similar vessel to the one involved in incident. Obtained on 1/3/2025 from manufacture's website.

Official Name:	N/A
Identification Number:	State Number: LA-8245-FZ HIN: UFQ02229H212
Flag:	United States
Vessel Class/Type/Sub-Type	Recreational Vessel (Gator Tail)
Build Year:	2012
Gross Tonnage:	N/A, estimated weight <1000 pounds
Length:	17' 0"
Beam/Width:	48" (estimated)
Transom:	21" (estimated)
Main/Primary Propulsion:	Gasoline Outboard (35 HP)
Owner:	[REDACTED]
Operator:	[REDACTED]
