MARINE SAFETY ALERT

Alert 04-10

Watertight Doors – Close Them and Dog Them!

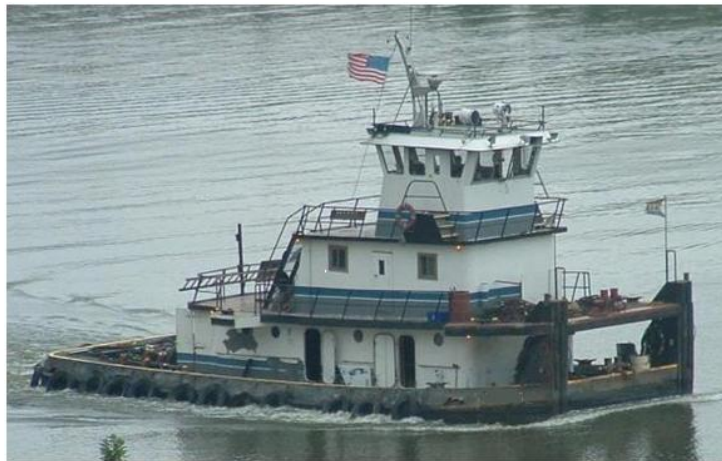
Not Actual Vessel

Recently a push boat operating “unfaced” (no barges attached) in the Houston Ship Channel flooded and sank while in the wake of tractor tug resulting in the death of the push boat crew and the narrow escape of two others. Although the investigation is not yet complete, it appears that the following occurred: The vessel’s watertight doors leading to its engine room had each been pinned open. The push boat had very little freeboard and was fully loaded with fuel and water. As it took the wake of the tractor tug, the vessel listed to one side and down flooded the engine room through a watertight door. As it rolled to the other side, it took on more water, eventually sinking stern first

and coming to rest on the bottom of the channel in an upright position. A person working in the engine room was trapped by the incoming water and drowned. Two others narrowly escaped death after being trapped in a berthing area for over 10 minutes, breathing only a pocket of air before taking dramatic efforts to reach the surface via a broken window.
