# PROCEEDINGS OF THE MERCHANT MARINE COUNCIL

## UNITED STATES COAST GUARD

September 1951

| | Page |
|---|---|
| XRA Buoys..... | 194 |

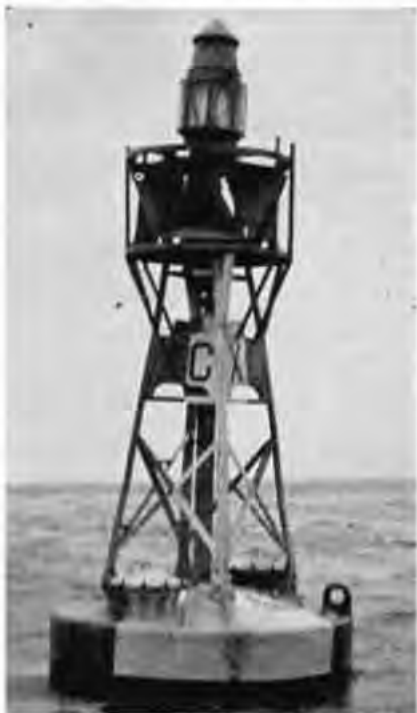
FIGURE 1.—Lighted whistle buoy with nest of eight Type "B" radar reflectors.

A detailed description of the type "B" buoy radar reflector is not reprinted here because of space limitations. The required supporting framework and number of reflectors necessary to cover 360° of the horizon, which varies from four to eight according to the size of the buoy, can be added without seriously affecting the flotation or stability of the buoy. (See fig. 1.) The additional cost of a single component of the type "B" reflector is approximately \$50, with the installed cost of an eight-reflector unit about \$600. This type of reflector is available to improve radar response of any existing buoy and, as later shown, of the XRA buoy. However, it is an item of appreciable additional cost which fact in itself tends to limit its widespread utilization.

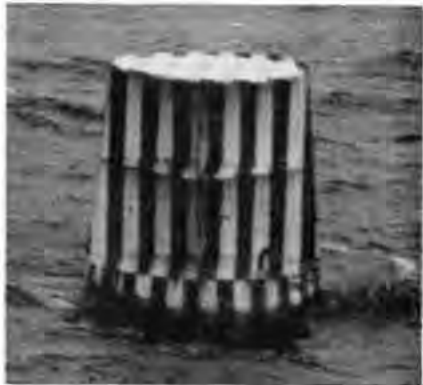
FIGURE 3.—"XRA" Type can buoy.

acteristics than the regular buoys. In February 1949 the Civil Engineering Division at Headquarters drew up designs of a can and nun buoy based on these concepts (now designated the "XRA" type, figs. 2 and 3) and one of each was fabricated at the yard. Shortly after completion they were planted off the New Jersey coast in the vicinity of Five Fathom Bank along with standard buoys of the same size and type for the purpose of collecting comparative data.
