# *PROCEEDINGS*

Vol. 21, No. 1 • January 1964

**COLLISIONS**

# COLLISIONS

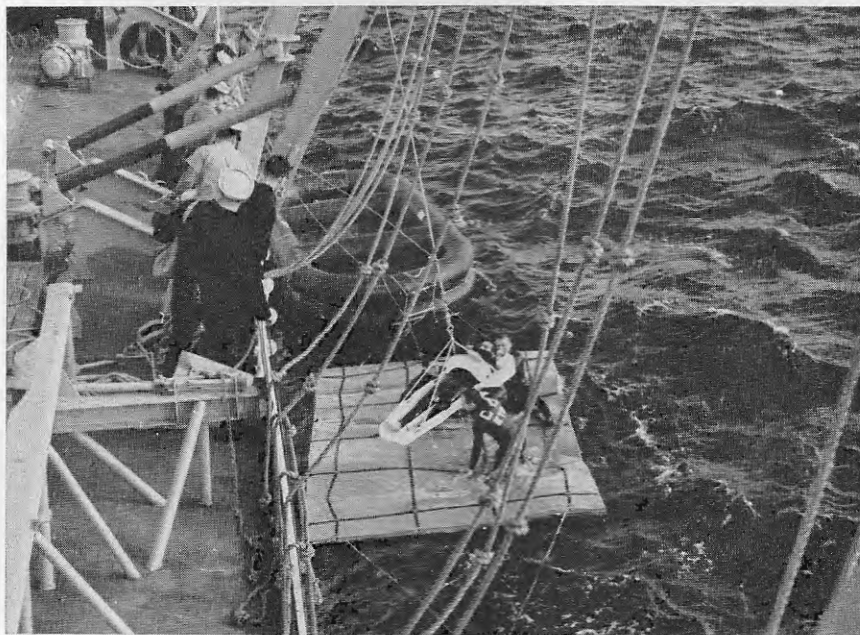
## RESCUE MAT

A NEW RESCUE MAT is being developed for the Coast Guard by the United States Rubber Co. The Coast Guard is testing this device primarily for use as a floating platform to be used alongside a vessel to facilitate recovery of survivors who are already in the water. The mat needs no inflation and takes only a few seconds to launch. It is not being developed for use as abandon ship or survival equipment. Improvements suggested by the Coast Guard are being incorporated into the design for further testing. This 4-inch-thick mat will have nylon straps extending over the sides to enable men to climb aboard, and devices are being developed so that the mat can be towed at either end.
