PROCEEDINGS

OF THE MERCHANT MARINE COUNCIL

Vol. 23, No. 7 * July 1966

Combustible Gas Indicators . . .

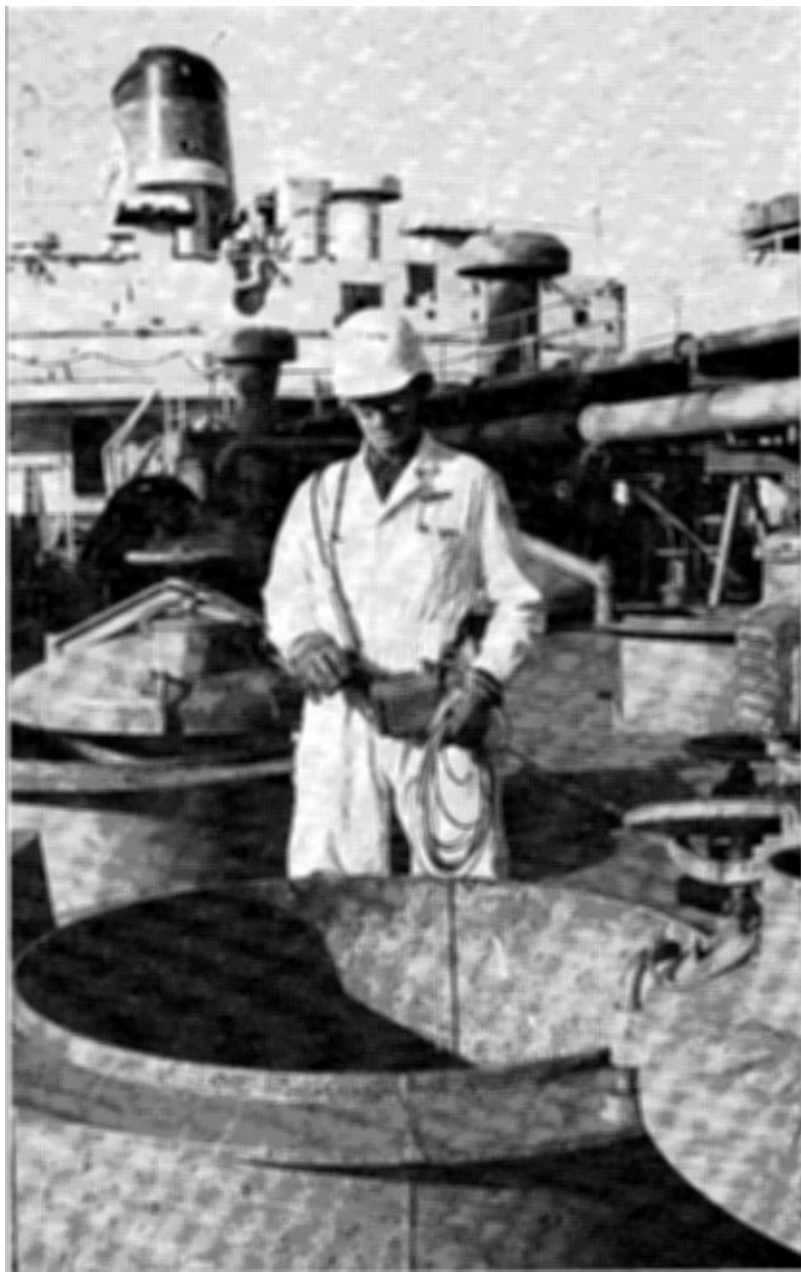
Courtesy Newport News Shipbuilding

Your life or the life of someone else may be dependent on the care with which you handle any combustible gas indicator. The sensing elements are only three one-thousandths of an inch in diameter, and the careless dropping of the instrument might very easily bend or distort the fine coils of these sensing elements, and thus, upset the calibration of the instrument. Then, too, the meter consists of a needle or pointer on a sensitive pivot. This pivot is mounted on a very small bearing. A severe jar may damage the pivot bearings.

First Step: Test for tightness.—Any time a filament is replaced in the analyzing chamber, or any other work done on the sampling system, the indicator should be tested for tightness before being assembled and put into service.

With a finger held firmly over the inlet of the instrument, squeeze the aspirator bulb and hold a finger firmly over the outlet valve of the bulb. If all connections are tight, the bulb will remain deflated. If the bulb inflates, there is a leak in the system and it should be found and remedied.

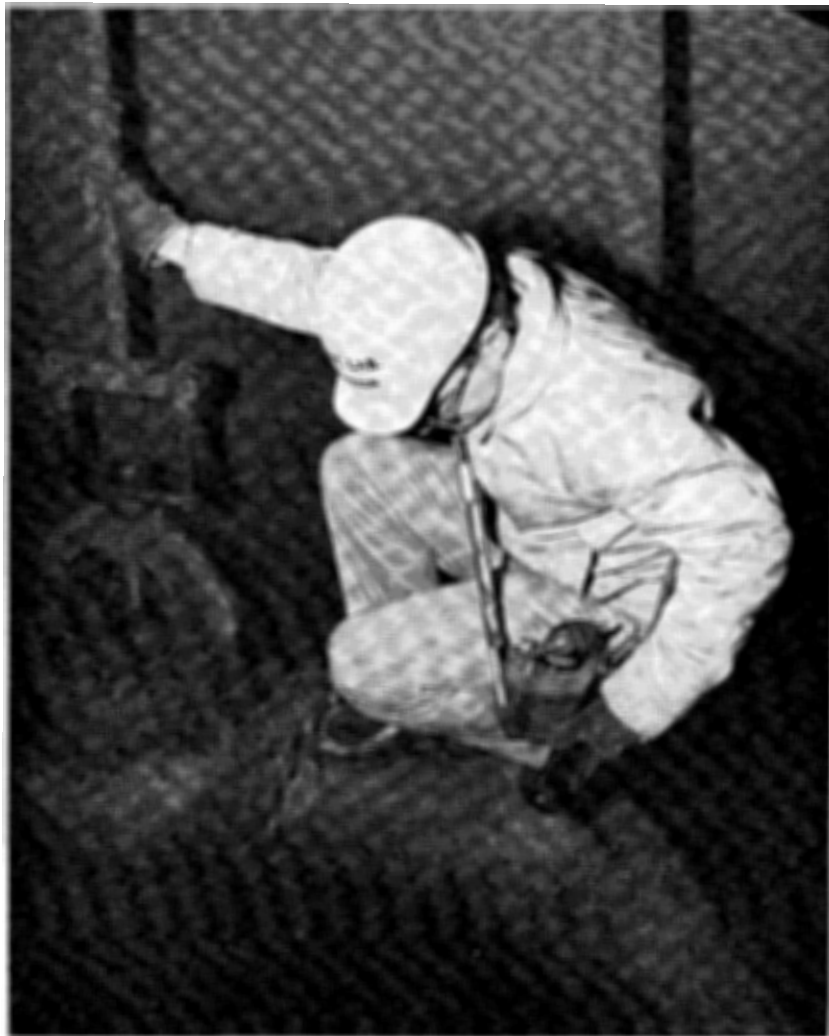
Courtesy Newport News Shipbuilding

A Liquid Trap is placed on the inlet of a gas indicator to keep all liquids out of the instrument. A ball rises with the liquid and sits on a fitting, thus stopping the liquid and/or gas sample before it reaches the instrument. The largest number of repairs required on all instruments has been caused by liquid entering the instrument.
