PROCEEDINGS

OF THE MERCHANT MARINE COUNCIL

UNITED STATES COAST GUARD
Vol. 23, No. 8 • August 1966

Built-in Safety in Ships . . .

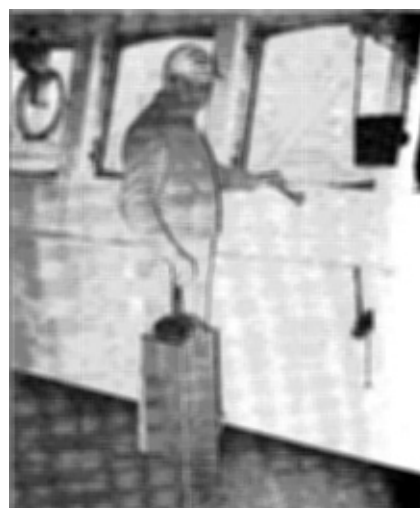
Figure 2.—Captain G. Didriksen, master Santa Lucia at bow thruster main control stand.
