PROCEEDINGS OF THE MERCHANT MARINE COUNCIL

Programs for Analyzing and Reducing the Influence of Personnel Failure on Marine Casualties . . .

SS *Glomar Grand Isle* Report . . .

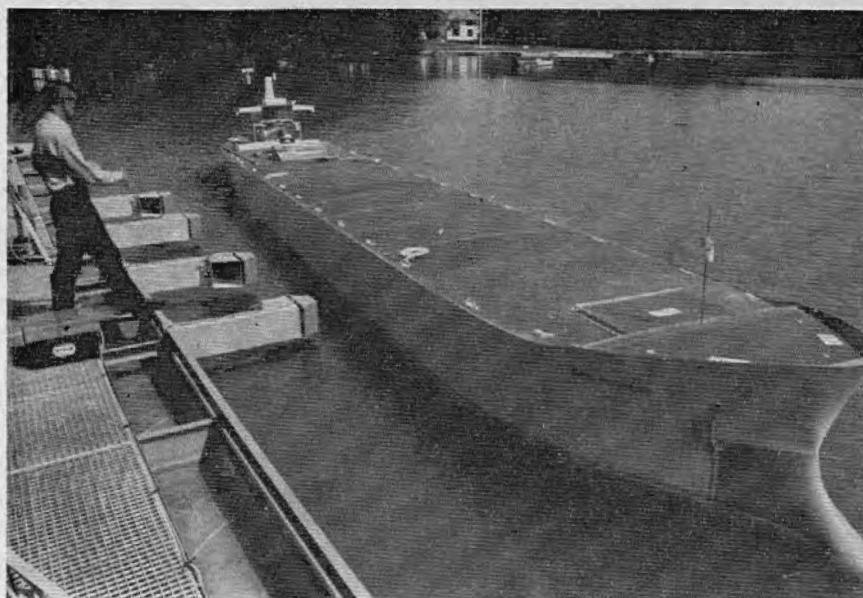
In the age of the supertanker, thorough personnel training is more vital than ever. To prepare men for handling the big ships, the Esso Marine Research and Training Center near Grenoble, France provides scale-model tankers in a variety of navigational problems. The largest of the models is the Esso Brittany, a 1/25th-scale copy of the 191,000-deadweight ton Esso Malaysia. The miniature vessel is 42.5 feet long, has a beam of 6.5 feet, draws almost 2.5 feet, weighs close to 14 tons, and will accommodate three men. The model performs exactly like its mammoth counterpart; its electric drive motors deliver the scale equivalent power of the big ship's engines. Electrical relays simulate time lags in engine and rudder orders.

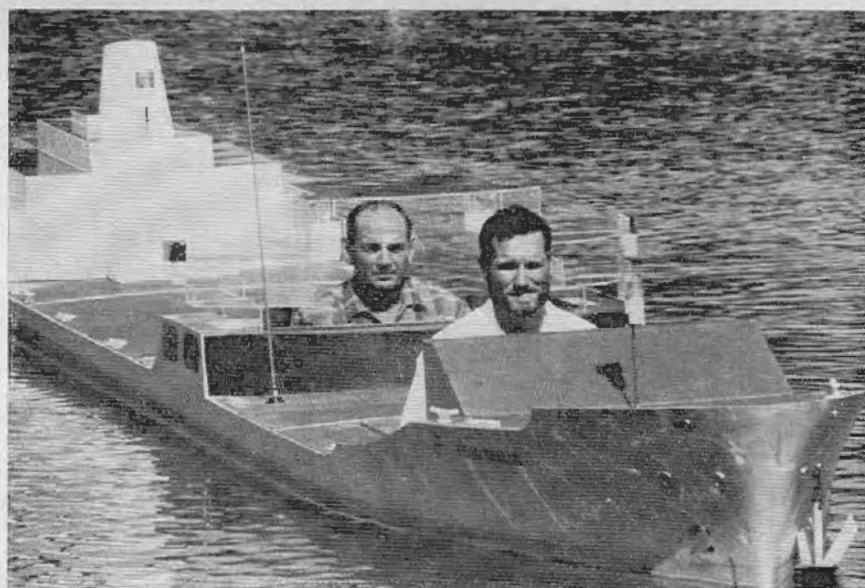
The two-man Esso Berlin is 26 feet in length and is a 1/25th scale model of its 38,000 ton namesake. The training center has facilities in the same 1 to 25 scale as the models. The layout includes a bend in the Suez Canal, two fixed bow mooring towers, a floating mooring buoy, two conventional buoyed sea berths, and lighted buoys to make channels.

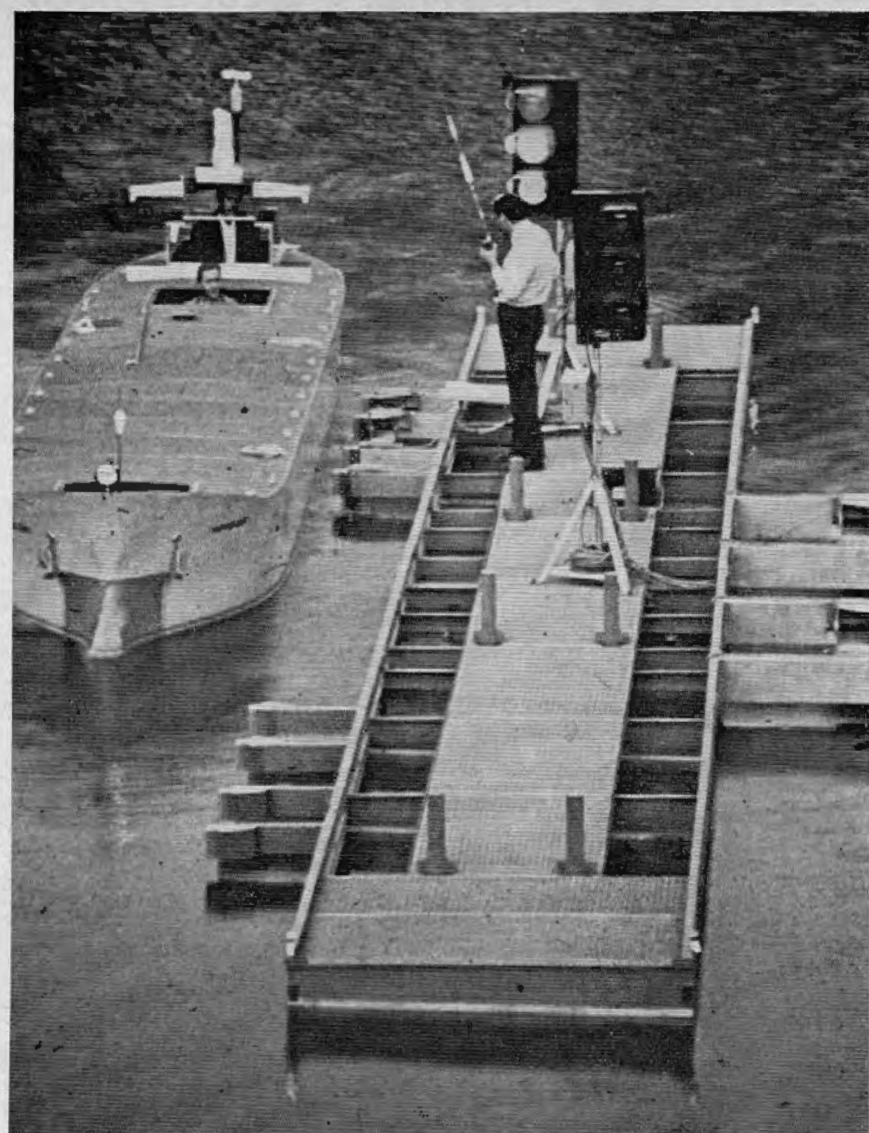
A model tanker approaches a special pier in a docking maneuver. The traffic lights at the end of the pier indicate the relative success of the exercise. If the captain brings the model in without mishap, the lights stay off. If he should nudge the pier, the green light goes on. A damaging jolt brings the yellow light on. If the red light should go on—a rare occurrence—it means that under actual circumstances the dock would have been destroyed.

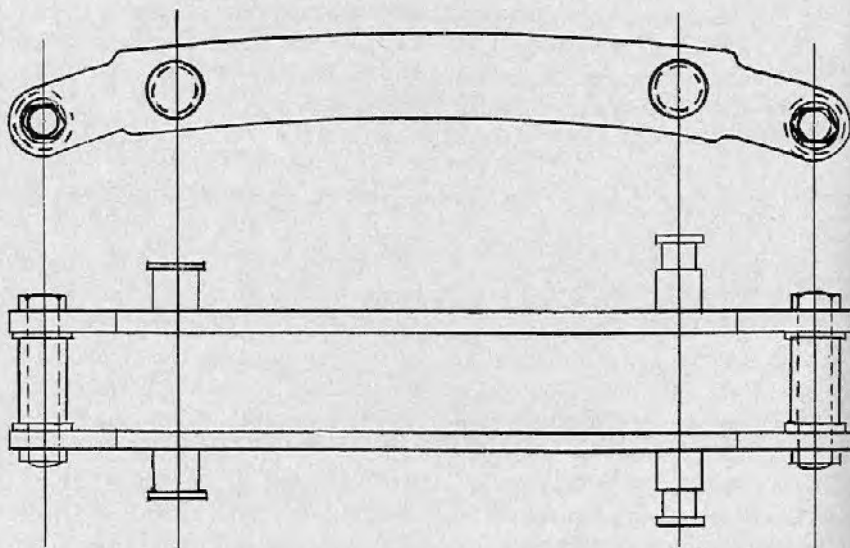
Q. Sketch the double-bar type Stephenson link.
