PROCEEDINGS OF THE MARINE SAFETY COUNCIL

DEPARTMENT OF TRANSPORTATION UNITED STATES COAST GUARD

January 1975

Tragedy on the Steele Container Safety Casualty Statistics

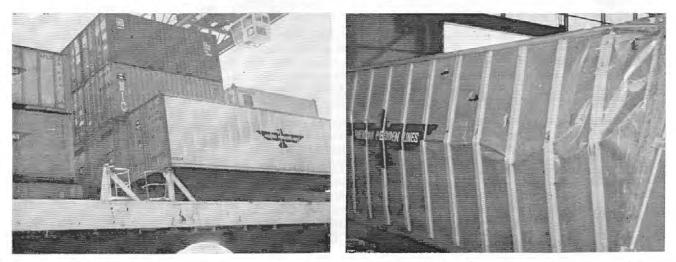
The blessings of containerized cargo are mixed, as the photographs above show. While the containers may be stacked on deck for fast and efficient transfer, they are subject to unique stresses. These stresses sometimes result in damaged cantainers, as shown in the photograph at right.

In a containerized cargo transportation system, the structural strength of the container is a very significant factor in the overall safety of the system. For instance, structural failure in the framework of a con-

tainer in a stack will inevitably result in collapse of that stack with possible injury to anyone who happens to be in the vicinity. Thus, there is a logical basis for an international agreement which sets mandatory standards of strength for containers used in international trade. The CSC specifies the structural requirements that containers used in international trade must meet to assure that they are safe. It provides for the periodic reexamination of each container and requires that the owner of each container accept responsibility for maintaining it in a safe condition. ("Owner" is defined as one who exercises the owner's responsibility for the container even though he may in fact be a lessee or bailee or be acting under some other contractual relationship with the true owner).
