# ***PROCEEDINGS***

**OF THE MARINE SAFETY COUNCIL**

International Ice Patrol . . . . .	48
Underkeel Clearance . . . . .	51
Annual Statistics of Casualties . . . . .	58

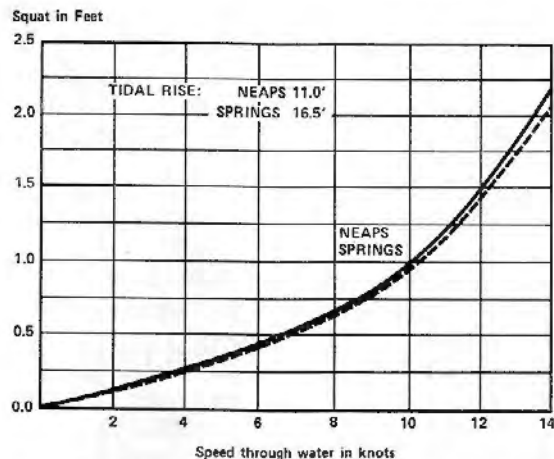
FIGURE 2.—The squat which calculation shows would be experienced in the Sea Reach Channel in the Thames (47,000 d.w.t. tanker on 37 ft. draft Yanlet Channel  $\frac{1}{2}$  mile east of sea reach No. 3 buoy at  $1\frac{1}{2}$  hours before local H.W.)

The author's company has been associated with model experimentation and practical tests over a number of years to determine the total amount of squat to which a tanker will be subject in any given circumstances. The subject has been very adequately covered in a paper presented to The Honourable Company of Master Mariners on 11 January 1967 by the author's colleague, Captain J. D. Rendle, but it is worth here, for illustration purposes, looking at the effects of squat in three typical channels (figures 2, 3, and 4).

These figures illustrate that for a given ship in a given circumstance, speed is a significant factor affecting squat. However, in confined channels a large proportion of the ship's power is used up in pushing the water past the ship between her sides and the bank of the channel, so that her canal speed is always substantially less than her sea speed for a given power, and there are many practical cases where ships do not have sufficient power to proceed at speeds which would give rise to values of squat great enough for the ship to ground. In fact, it is generally true in practice that ships in confined channels are much less likely to ground due to squat than are ships with small underkeel clearance in relatively unconfined waterways.
