PROCEEDINGS

OF THE MARINE SAFETY COUNCIL

September-December 1977

The Sinking of the Edmund Fitzgerald

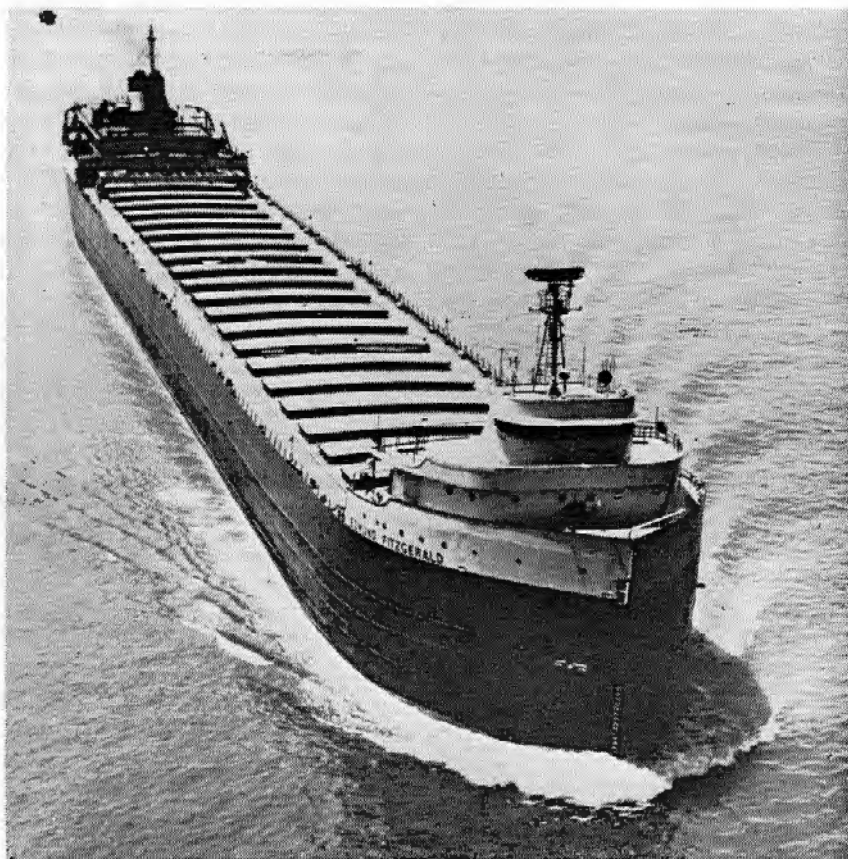
they "wanted to be 2 to 2½ miles off Whitefish Point." The mate on the *Anderson* estimated that, with the drift, *Fitzgerald* was probably headed for that position.

The mate on watch took a fix at 5:01 p.m. and noted that the *Fitzgerald* was 15 miles ahead and "just a shade" to the left of the *Anderson*'s radar heading marker. He informed the *Fitzgerald* that Whitefish Point was 35 miles ahead on a bearing of 144°T from *Fitzgerald*'s position. The *Fitzgerald* acknowledged this information and indicated that
