The Costa Concordia Shipwreck Summary of Emergency Response Management

The Costa Concordia Shipwreck

Summary of Emergency Response Management

Ву DAVID FABI Dipartimento della Protezione civile — Ufficio gestione delle emergenze

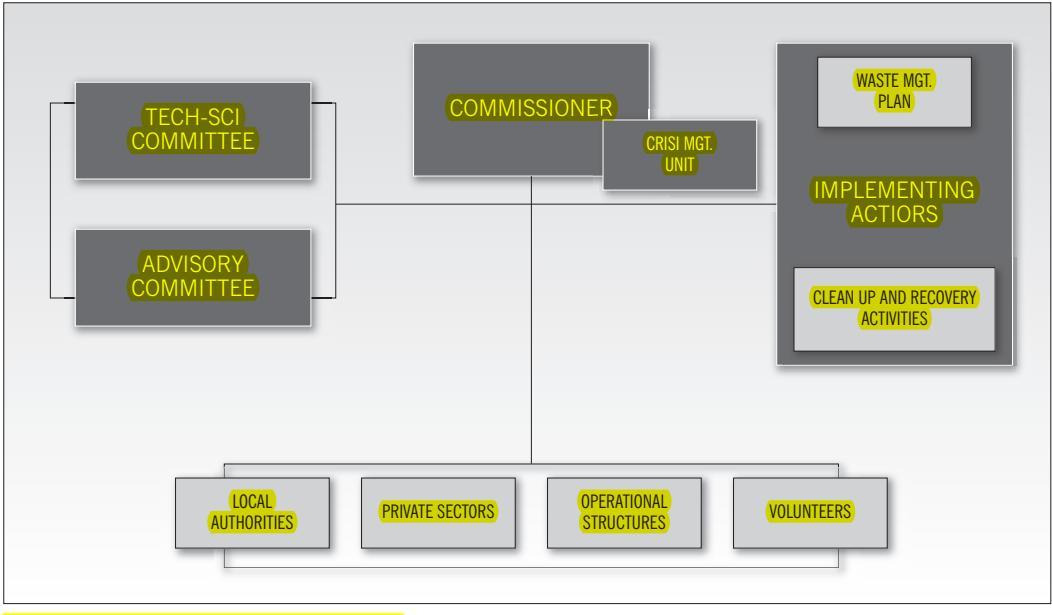
Fig 1 – Emergency response model adopted by the CD

Below is the emergency management response model adopted for Concordia originating expressed in OPCM 3998 and the response organization of the national civil protection. The complexity of the model is apparent from the large number of actors required to provide a clear answer to emergency management.

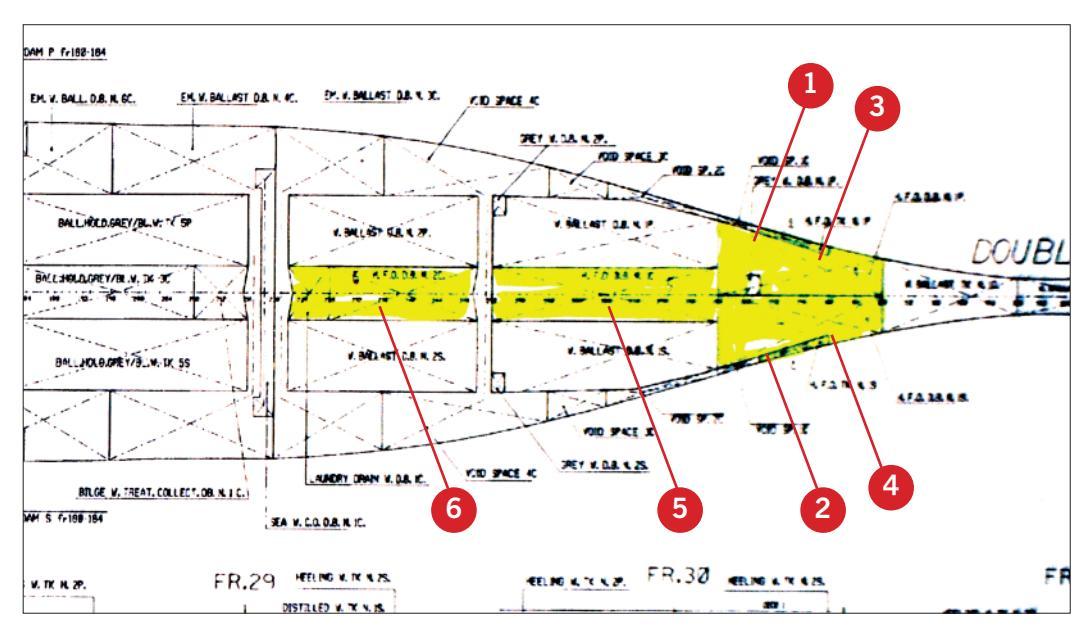
Fig 3 -Location of bow section tanks in DB

Fig 3 shows the location of the bow section tanks DB (Double Bottom): Pumping from DB started at 16:55 on 12 February 2012 and was completed 19 February 2012 at 16:00. The operation worked around the clock due to favorable weather conditions and approx. took 7 days to empty the tanks. The quantity of HFO in the bow section tanks was 1308,6 mc, which differed from the ship's engineer approx. by 209 mc. This difference is partly due to adhesion to fuel tank walls that cannot be removed due to physical and mechanical extraction limits: this quantity is estimated at approx. 10/20 m/c per tank. The yield was also slightly lower in view of the fact that fuel was pumped out directly and using hot tap technology. With the hot tap technology the dispersal was unforeseen. Therefore the company decided to limit the extraction yield and not draw directly. The possibility of using other techniques was considered, but because they involved perforating the hull thus impairing the stability of the vessel they were abandoned;

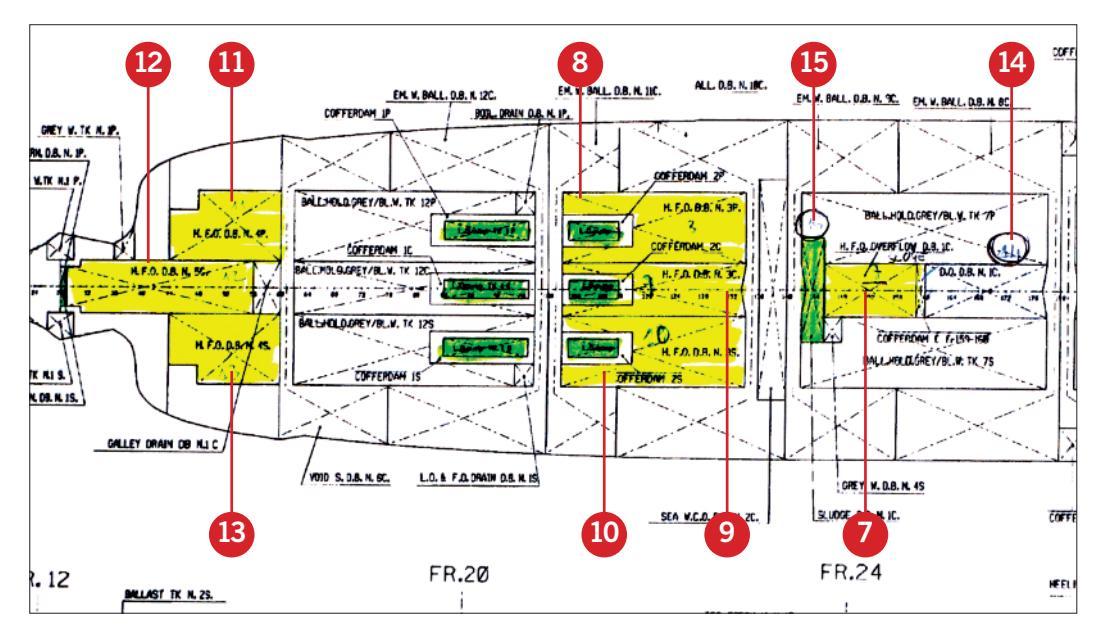
Fig. 4 – location of central and stern tanks

Tanks located in the upper level to those of phase 1 and 2. Their capacity was estimated at 348 cubic meters. Deck C (engine room) proved to be complex, due to the difficulty the divers encountered in reaching the tanks.

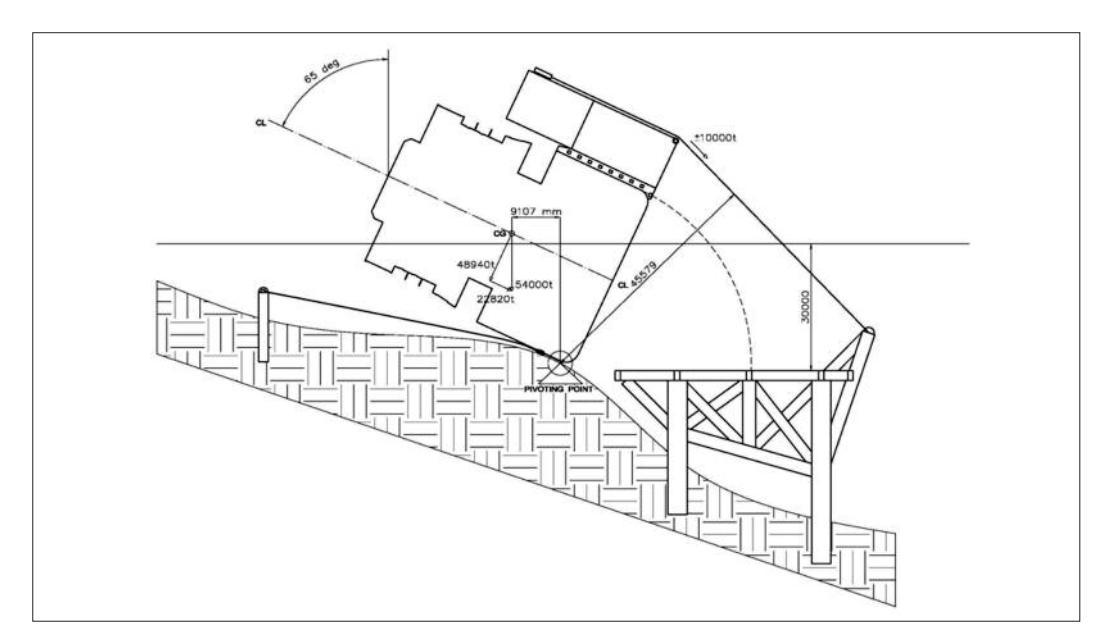
Fig 5 - Configuration of the hold back, parbuckling and buoyancy system

Of particular importance in the removal project context, is the hold back system of the ship which operates via steel cables, jacks and pylons driven into the seabed along the coast, in order to ensure that the operation proceeds safely for ship operators and to ensure the stability of the vessel even in adverse weather conditions.

Fig 5 describes hold back, parbuckling and buoyancy system.
