M/V Triple Crown . . .

A Universal System for the Tonnage Measurement of Ships	211
Changes in Reexamination Procedures	214
M/V Triple Crown Sinking with Loss of Life Santa Barbara	
Channel, 25 November 1968	215
DEPARTMENTS	
Nautical Querics	223
Amendments to Regulations	225

# A UNIVERSAL SYSTEM FOR THE TONNAGE MEASUREMENT OF SHIPS

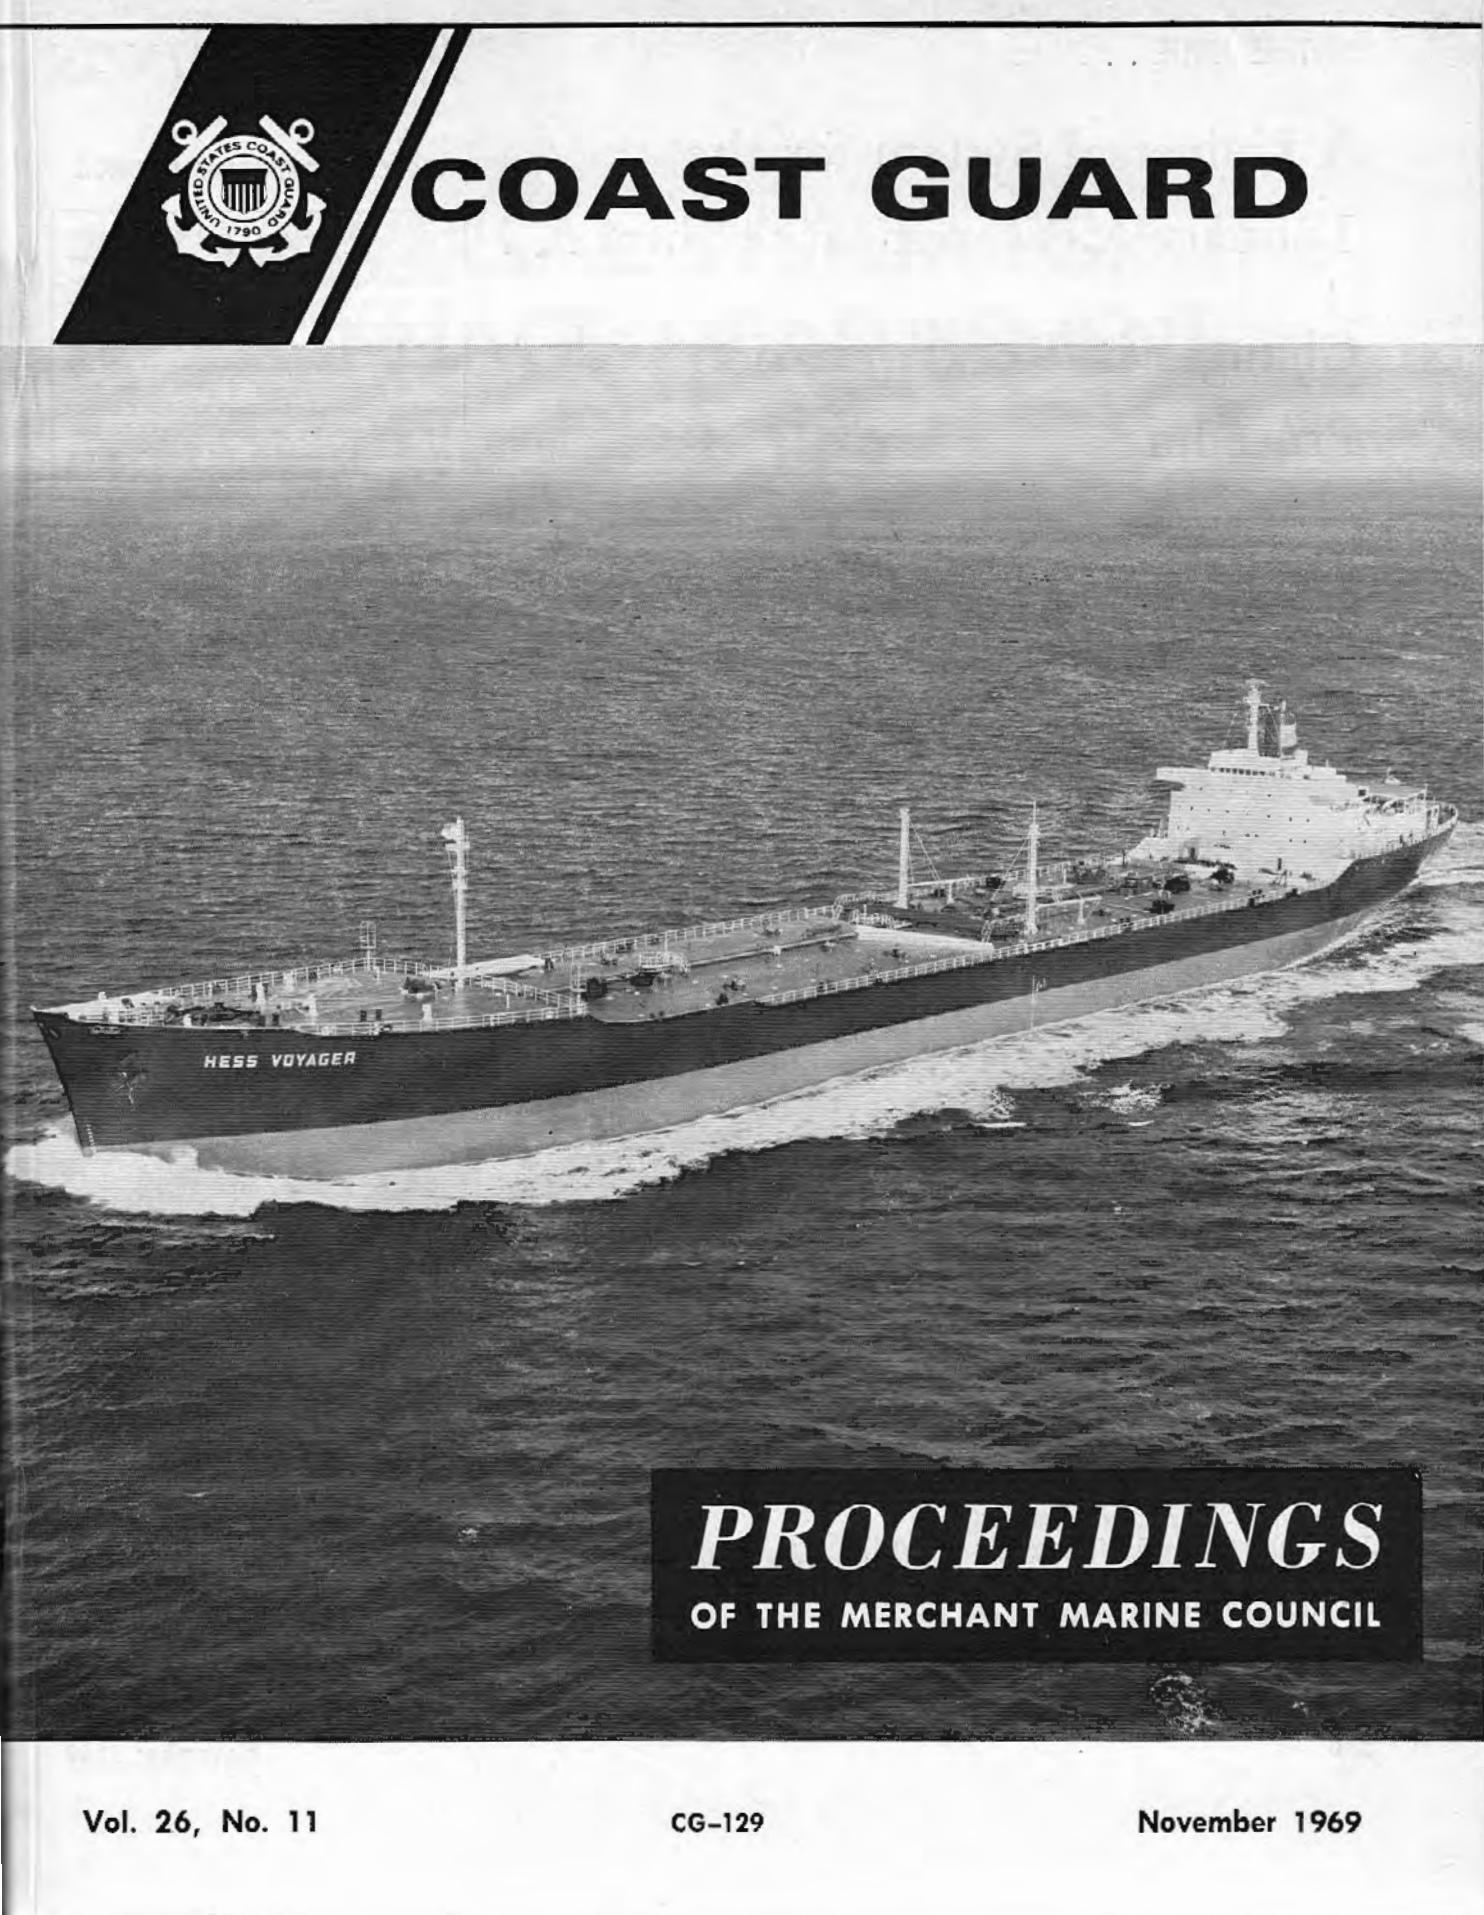
FRONT COVER: The SS Hess Voyager underway. Delivered in 1964 by the Sparrows Point, Md., shipyard, the 48,500 deadweight ton tanker steams at 16½ knots. She is 736 feet long, has a beam of 102 feet and a depth of 50 feet. She is the second tanker to bear the name, the first having been decommissioned in 1963.

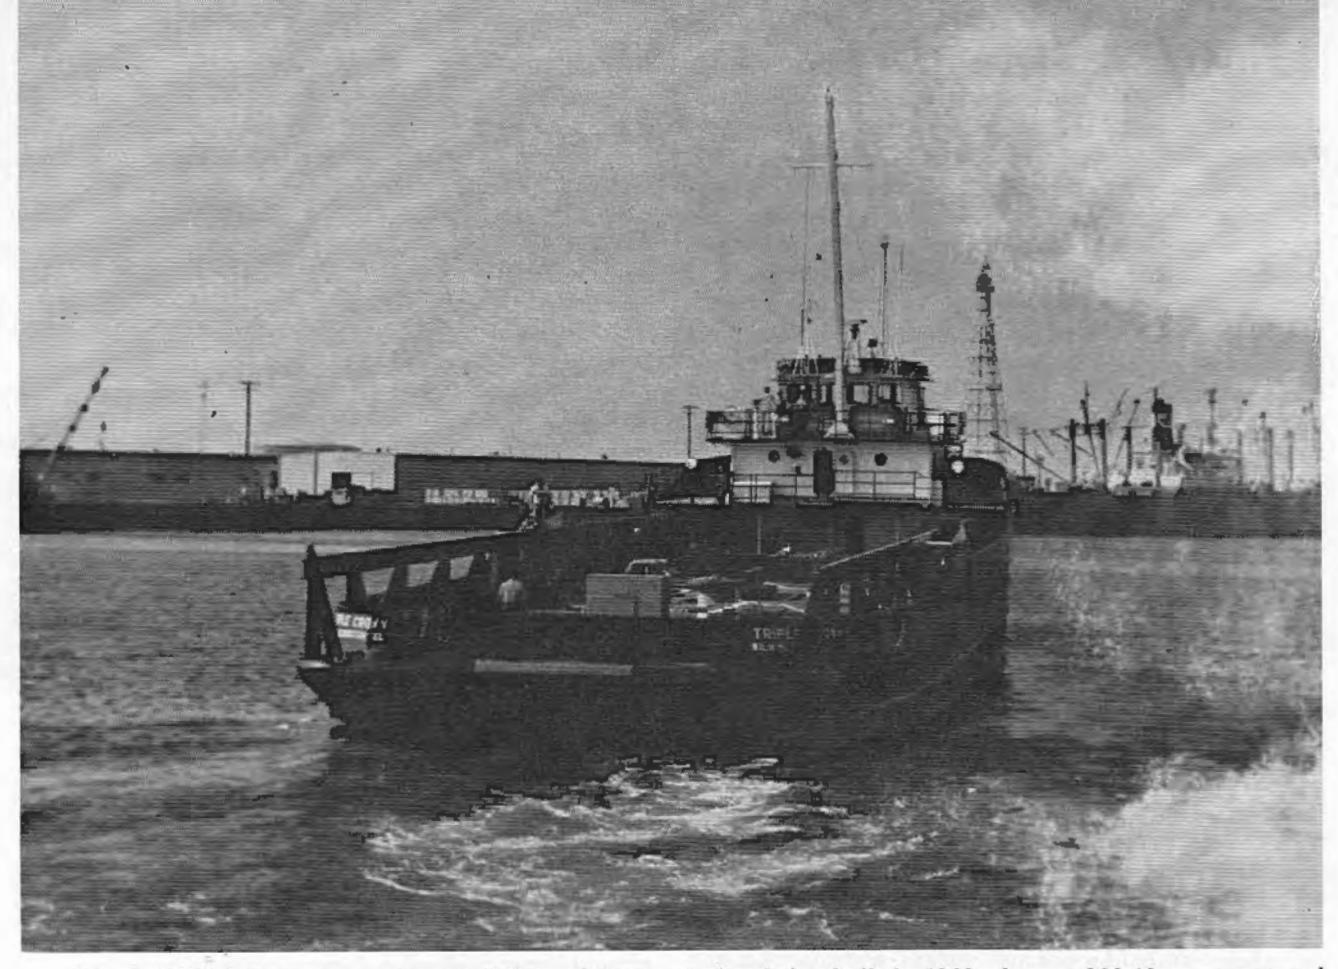
The M/V Triple Crown underway. When admeasured after being built in 1968, she was 288.19 gross tons and 195 net tons. After admeasurement, four of her exempted water ballast tanks were converted for the stowage of anchor chain, and two ballast tanks were converted to fuel oil tanks. In addition, the wing tanks, port and starboard, were converted to domestic water. These changes added 207.66 tons to the gross tonnage.

4. When building of the M/V Triple Crown was completed at Port Arthur, Tex., the M/V Triple Crown was admeasured on 30 August 1968 and found to be 288.19 gross tons and 195 net tons. Subsequent to being admeasured, she proceeded to Port Hueneme, Calif., where four of the exempted water-ballast tanks were converted for the stowage of anchor chain and two ballast tanks were converted to fuel oil tanks. In addition, the wing tanks, port and starboard, were converted to domestic water. These changes added 207.66 tons to the gross tonnage.

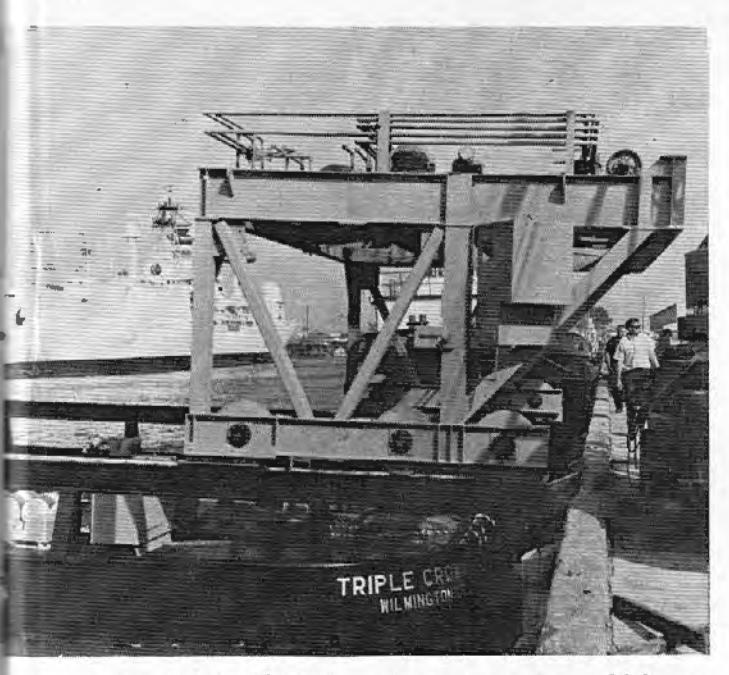
The M/V Triple Crown's gantry crane, which was capable of moving fore and aft on its rails. The crane was used in hoisting anchors aboard and stowing them on deck.
