PROCEEDINGS

MERCHANT MARINE COUNCIL

THE ANATOMY OF MARINE CASUALTY INVESTIGATIONS

A discussion of significant marine casualties of 1969 in the context of the casualty investigation program and its aftermath.

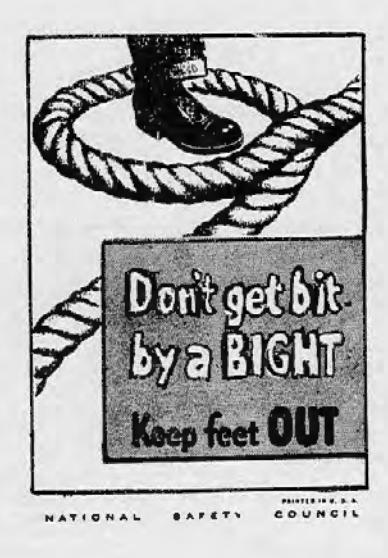
Good communication is most important. The seamen at the controls of the windlass must be alert and have a clear view of all hands handling the lines.

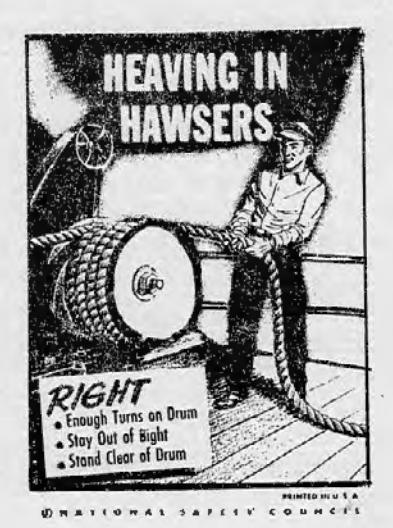
Always make mooring lines fast to bitts, not on gypsyheads.

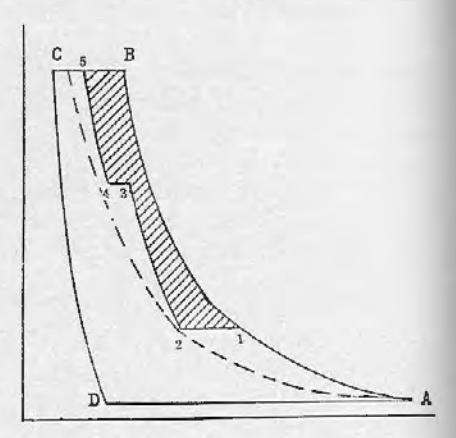
Q. Copy the below diagram and label each of the lines. What does the cross hatched area represent?

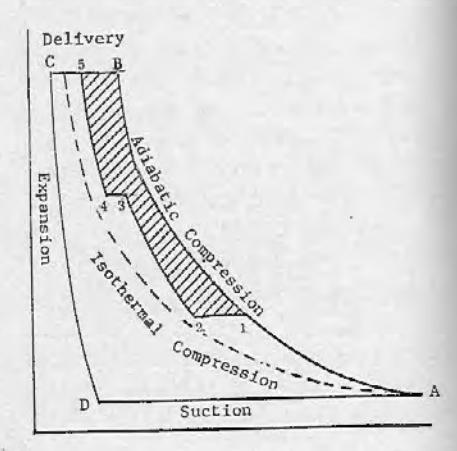
A. The below diagram indicates three methods of compression: isothermal, three stage with intercoolers, and adiabatic. The cross hatched area represents the work saved by three stage compression with intercooling versus single stage adiabatic compression.

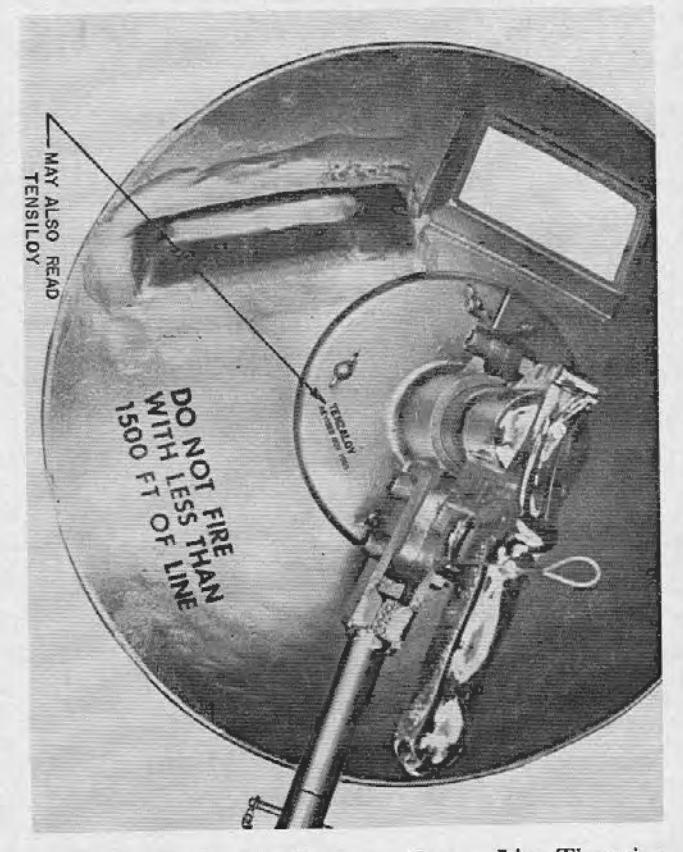
Enclosure (1) To NAVIGATION AND VESSEL INSPECTION CIRCULAR NO. 8-69.

Impulse-Projected Rocket Type Line-Throwing Appliance.

During June 1969 a Notice to Mariners and an instruction to inspection personnel were issued reconfirming the suspension of quarterly drills with the subject appliance. After investigation and conducting tests on the appliance, it was determined that the reported failures were in the shield support bracket. Repeated tests with a new shield support bracket made of "TENZALOY" could not duplicate the failures.

If it is determined that the shield support bracket is not of the new material, a replacement bracket may be ordered directly from the manufacturer, Kilgore Corp., Toone, Tenn. 38381, at a cost of \$3.50 F.O.B., Toone, Tenn.
