MARINE SAFETY ALERT

Alert 9-08

ELECTRONICALLY-CONTROLLED CARGO PUMP ENGINE COMPONENTS

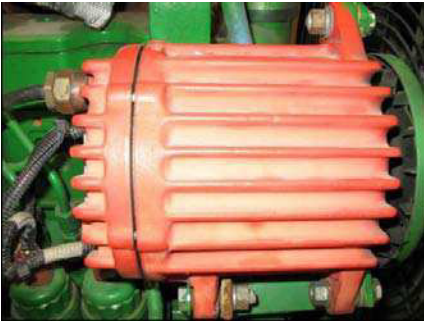
Alternators: If an alternator is used, it should be an approved flameproof or explosion proof alternator.

Typical flame proof /explosion proof alternator.

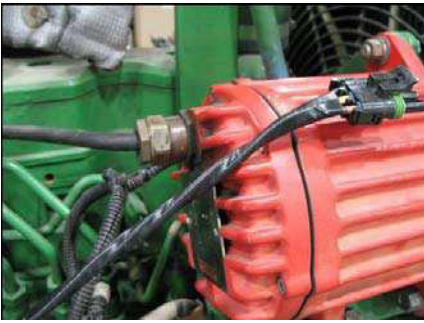
In some installations, cables between the alternator and battery were cut and a connector put in place to allow easier servicing. This alteration is not appropriate for hazardous locations. The cable seal on this alternator may not be the one approved for the alternator and may have to be examined.

Cable entries on flameproof or explosion proof enclosures require sealing fittings that are suitable for the enclosure.

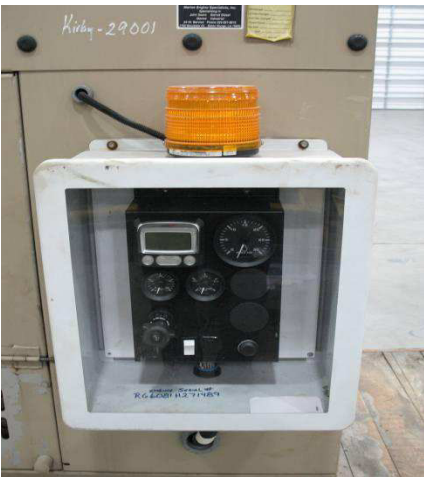
Typical unacceptable electronic display. This is not in an explosion proof enclosure. The beacon installation shown here outside of the enclosure is also unacceptable.

Electronic displays should be enclosed in explosion proof enclosures.

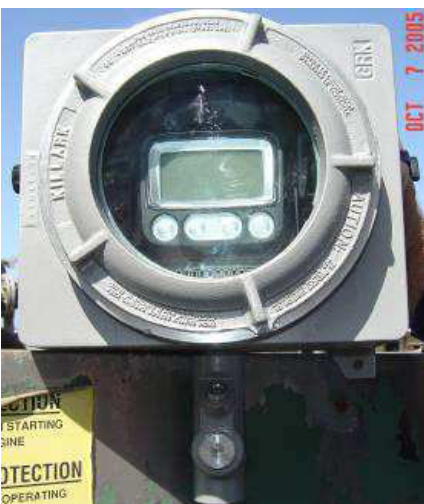
Typical acceptable electronic display – This particular one was approved by the Marine Safety Center (John Deere Part No. RE531478)

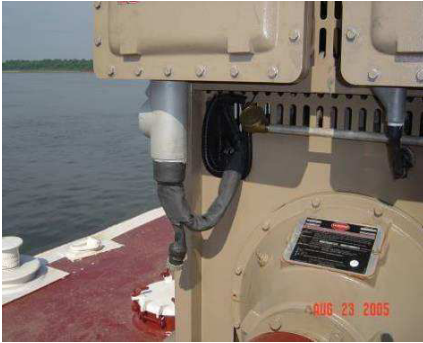
An acceptable engine control unit (ECU) enclosure is shown here with a sealing compound installed in a proper cable gland. Sealing compound poured in the conduit or cable seal fitting should surround each individual insulated conductor and the outer jacket of the cable, unless the cable is gas tight. Cables should be prevented from being pulled out of the conduit or cable seal fitting.
