## **MARINE SAFETY ALERT**

### **Sector Houston-Galveston**

**Alert 01-11**

### **Mooring Line Operational Safety**

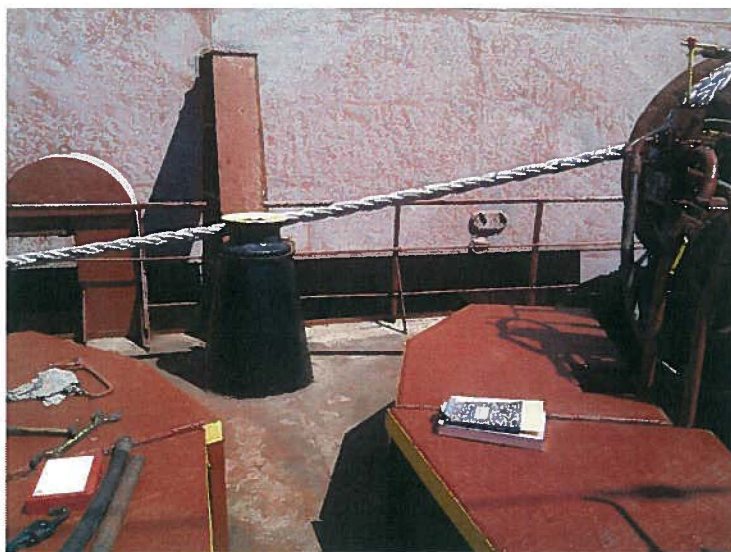
Proper use of deck fittings i.e. buttons, kevels, cleats, rollers and bitts provide near unlimited mooring arrangements; they also create the potential for dangerous latent unsafe conditions. Casualty investigations have revealed the improper application of deck fittings has caused mooring lines to spring/slip free off the fitting. Specifically, arrangements lacked a substantial bend and/or had an excessive angle prohibiting the line from holding tight against the deck fitting.

Image: Note: This line sprung/slipped off the roller. The angle of the line requires a taller roller bit structure for proper fit.
