## **MARINE SAFETY ALERT**

Safety Alert 06-18

### **Don't Let Your Vessel Get Underway Unexpectedly! Bollard Failures at Marine Facilities**

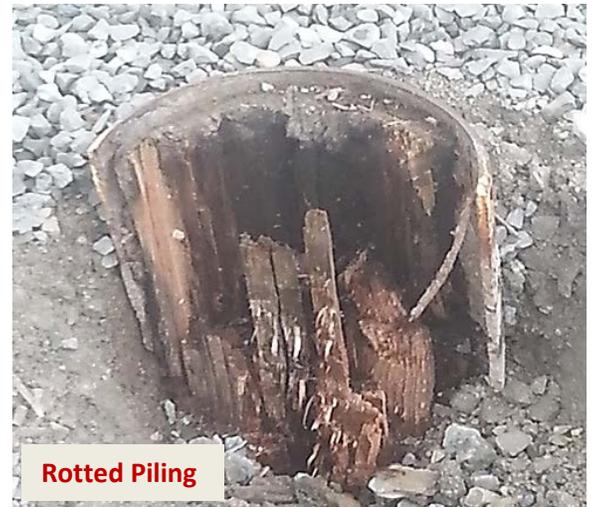
**Rotted Piling**

The Coast Guard **strongly recommends** that facility owners and operators take steps to develop a routine inspection program for bollards and other mooring equipment. Furthermore, vessel personnel should report discoveries of apparently deficient shore side mooring equipment to facility managers.

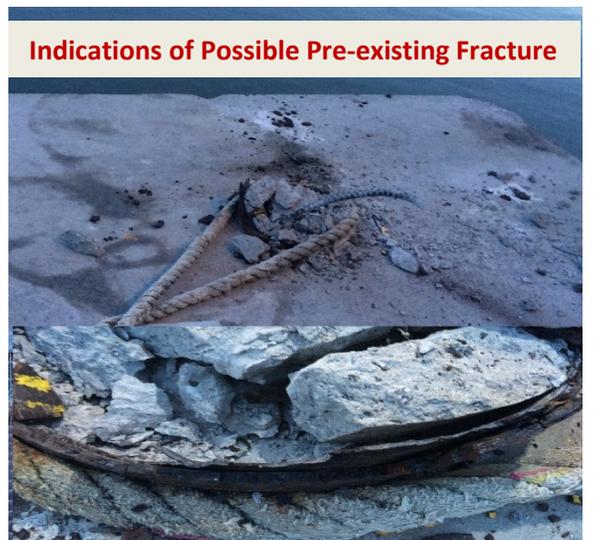
**Indications of Possible Pre-existing Fracture**

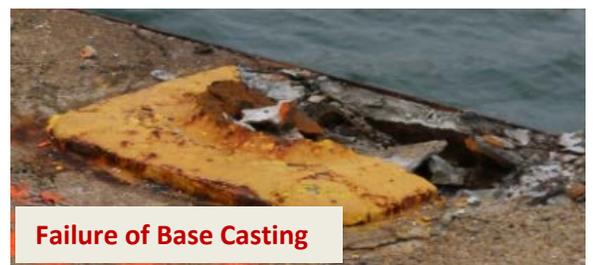
**Failure of Base Casting**
