MARINE SAFETY ALERT
Inspections and Compliance Directorate

Safety Alert 07-23

**CRITICAL INSIGHT FROM ONGOING INVESTIGATIONS
INTO SMALL PASSENGER VESSEL FIRES**

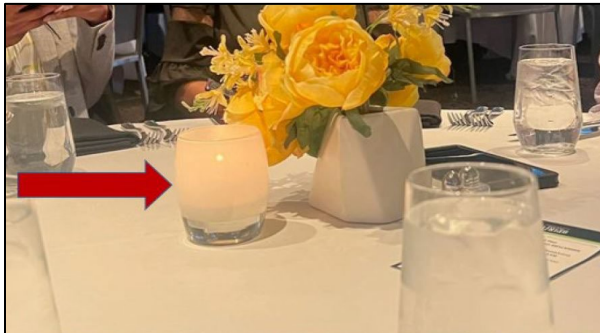
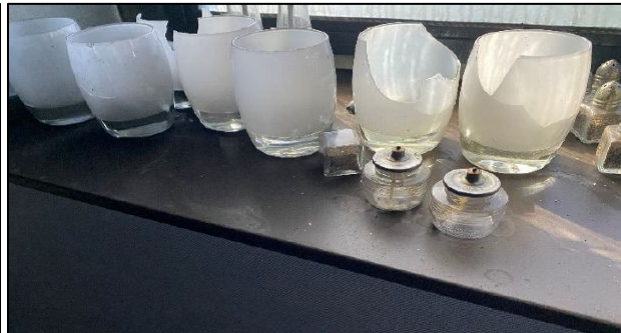
Open Flame Caution: During dinner cruises, the hospitality personnel used open flame, liquid paraffin fueled candles in glass sconces on dinner tables, as well as wax birthday candles for celebrations on desserts. Alternatives for open flamed table lighting, such as battery powered lights, are widely available and inexpensive. These alternatives should be considered by entertainment personnel onboard passenger vessels.

Figure 1: Open flame table lamp (left) and recovered sconces and paraffin table candles (right).

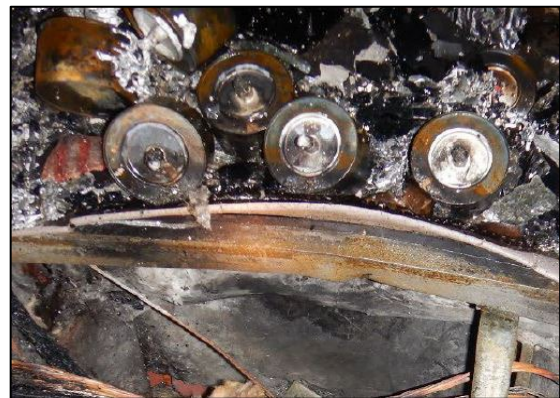
Sterno® Heating Cans: Sterno® cans are used under chaffing dishes to heat food and coffee. Sterno® cans will remain hot for an extended period after extinguishment and should be handled carefully so that they are allowed to cool before moving or storing. Vessel operators should consider strategies to ensure that cans are cooled properly and the flames are fully extinguished after use. Operators should also consider other possible alternatives such as fire-free (flameless) heating units or air-activated warmers.

Figure 2: Post fire images of ***Sterno®*** cans stored in server station of the vessel.

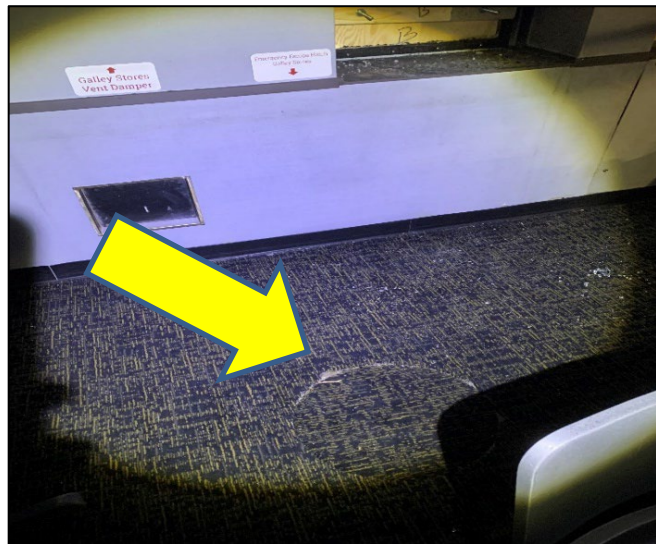
Engine Room Escape Hatch Coverings: In one of the fires, firefighters were unable to locate the engine room escape hatch on the main deck of the vessel. Evidence in the other fire also indicated that circular hatches in the main deck were covered with the same patterned carpet, making the location hard to distinguish. While regulations do not require additional marking, there were no additional markings on the deck in the vicinity of the hatches to allow passengers, crews, and potential emergency responders to rapidly identify the location of the hatches. Hazard tape or other floor marking tapes are recommended to clearly delineate the location of the hatch.

Figure 3: Escape hatch (yellow arrow).

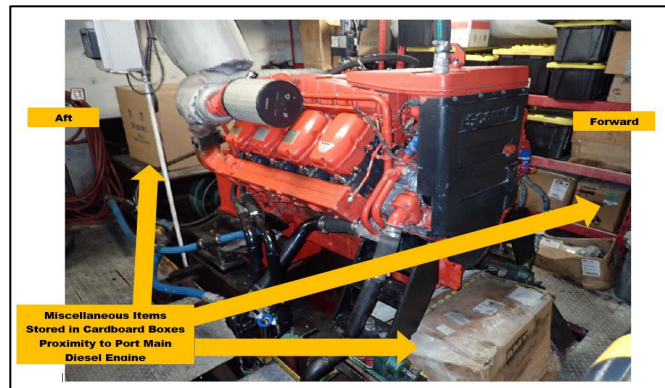
Combustible Material In Close Proximity To Ignition Sources: In one of the fires, a large quantity of combustible cardboard boxes and plastic storage bins were stored in close proximity to potential ignition and heat sources. Operators should inspect machinery spaces to ensure that combustible materials are properly stored as far away as possible from potential sources of ignition, including the vessel’s engines and machinery.

Figure 4: Combustible materials stored in the engine room.
