### **Office of Investigations and Casualty Analysis**

Findings of Concern 006-19

## **Impacts of Modifications, Alterations and Weight Creep on Stability**

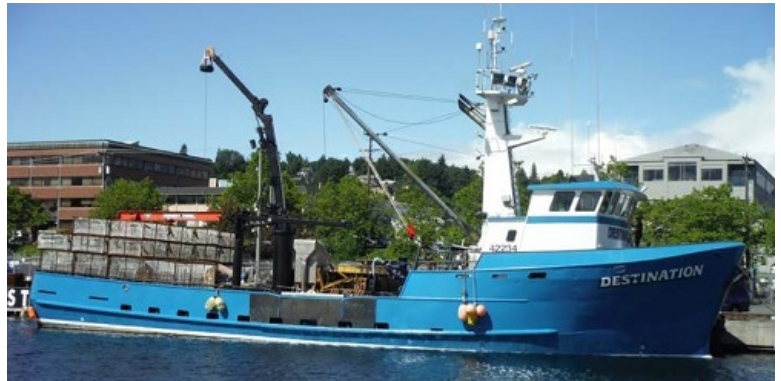
The Incident. In February 2017, immediately after 27 days of cod fishing, a 98 foot commercial fishing vessel carrying 200 crab pots with a crew of six departed Dutch Harbor, Alaska, and proceeded towards St. Paul Island to drop off bait with the intent to transit to the Opilio crab fishing grounds. The vessel got underway despite multiple National Weather Service (NWS) marine forecasts indicating areas of freezing spray throughout the vessel’s planned route. After sailing for about thirty hours and while approximately 4.4 miles off of St. George Island, automatic identification system (AIS) data showed that the vessel’s speed abruptly slowed and its heading swung hard to starboard into the prevailing seas and northeastern winds. Shortly thereafter, the vessel appeared to suddenly lose maneuverability. Its heading pivoted to the west, the vessel drifted to the north and sank, taking the lives of all six crew members.

Contributing Factors and Analysis. The investigation showed that the owner failed to properly use the services of a qualified individual to formally evaluate and update vessel stability instructions following changes to vessel structure and loading conditions. These included:

- installation of a bulbous bow,
- addition of bulwark on the bow, and
- use of larger, heavier crab pots.

The weight of the larger, heavier crab pots exceeded that of the pots used to formulate the existing and most current stability instructions. Although investigators do not know if the vessel master referred to existing stability instructions for operating the vessel, but the instructions were incorrect, and any decisions based on them would have been faulty. Additionally, a decision to place an additional 3,080 pounds of crab bait on top of the 5 tiers of stacked crab pots, raised the vessel’s center of gravity and further reduced the vessel’s stability. The Coast Guard believes that these issues, combined with the master’s decision to depart port with a fatigued crew, active NWS freezing spray warnings in the area of transit and in a heavily loaded condition, negatively impacted the vessel’s stability, contributing to the vessel’s capsize and sinking.

- Owners, operators, and masters should maintain an active awareness of vessel stability issues at all times, including the need for qualified individuals and naval architects to update stability instructions and booklets when structural changes are made to a vessel, other equipment or operational gear is changed, or their placement is altered. Furthermore, qualified individuals and naval architects should take the opportunity when stability instructions and booklets are updated to examine the vessel's stability history to ensure previous stability calculations were sound and are suitable to continue to serve as a solid basis for any changes and updates.

- Owners, operators, masters, qualified individuals, technical superintendents and other personnel need to remain fully cognizant of "weight creep," which is the result of modifications and alterations to the vessel that occur over its lifespan. Modifications and alterations may occur due to changing fisheries, fishing methods, variations in equipment and area of operation. These weight changes impact stability, and ultimately create the need for a qualified individual to revisit the stability instructions and associated calculations.

- One way to prevent "weight creep" is to develop a Modification and Alteration Log which can be maintained in various formats. The log can be as simple as a notebook or spreadsheet, or in the form of computer software. The vessel's existing stability instructions and data should be first validated by a qualified individual or naval architect prior to creating a log to ensure future stability calculations start from an accurate baseline.
