## **Best Practice: Concrete Posts and Fencing Added to Breakwall**

<b>Category:</b>	Perimeter Control
<b>Location:</b>	Dakar, Senegal
<b>Date Observed:</b>	October, 2005
<b>POC:</b>	Mr. Bara Sady General Manager Dakar Port Authority 221.849.45.01 sady@portdakar.sn

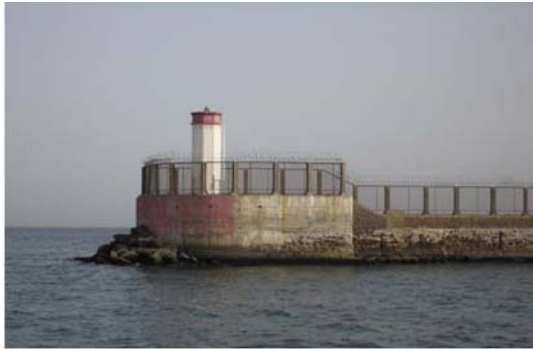
**Description:** The port has constructed a ten foot poured concrete-chain link fence with a two foot concertina wire topper along the perimeter break wall of the facility. The break wall forms a physical barrier along the waterside perimeter of the port. The addition of this wall creates an impregnable barrier further increasing perimeter security.

**Discussion:** At a waterfront facility a common challenge to the effectiveness of walls and fences is the land and water interface, and how to prevent intruders from gaining access into the facility via the break wall. At the Port of Dakar, this issue was addressed by adding a poured concrete wall along the entire length of the break wall. This wall creates an additional level of security to the existing break wall.

**Potential Downside:** A wall of this type is susceptible to erosion from tidal forces. Concrete walls are expensive to construct on break walls and require regular maintenance to sustain their physical integrity.

**Conclusion:** In most places, the existing break wall suffices for an adequate level of perimeter security. The addition of a barbed wire concrete wall enhances perimeter security, further increasing the level of difficulty required to gain access to the facility.
