## **Best Practice: Infrared Motion Detection Device and Audible/Visual Alarms**

<b>Category:</b>	Security Infrastructure
<b>Location:</b>	Romportmed, Port of Galati, Romania
<b>Date Observed:</b>	December 2006
<b>POC:</b>	Mr. Iancu Boldea, Chief of Port Security Bureau, The Ports Administration on the Maritime Danube, Port of Galati
<b>WWW:</b>	<a href="http://www.romportmet.ro">www.romportmet.ro</a>

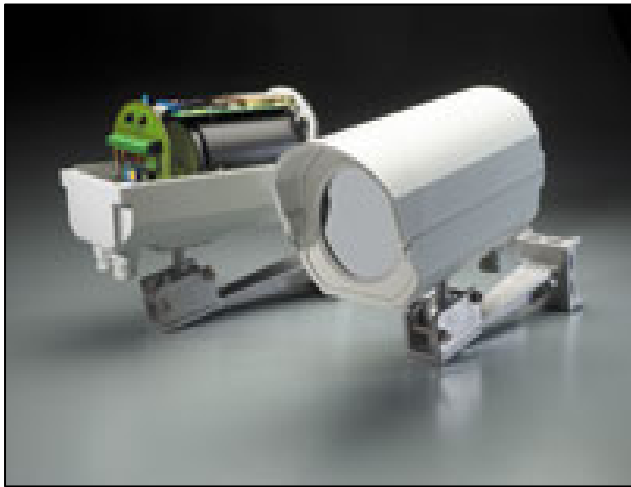
*File photo; not taken in Romania.*

**Description:** The port facility has a state-of-the-art infrared motion detection device directly interfacing with a joint audible/visual alarm system. This innovative infrared motion detection alarm system focuses on the ship-port interface, hence its location at both ends of the operational pier. The audible/visual alarms are located throughout the port facility to enhance the response of security personnel in case of a breach of security at the ship-port interface area.

**Discussion:** The main control instruments for the infrared detection device and alarms are located in the security office, which is within the main Romportmed administration building.

**Conclusion:** The use of this intrusion detection and alarm technology provides employees with immediate awareness of specific security breaches at the ship-port interface.
