# PROCEEDINGS OF THE MERCHANT MARINE COUNCIL UNITED STATES COAST GUARD

August 1954

No. 8

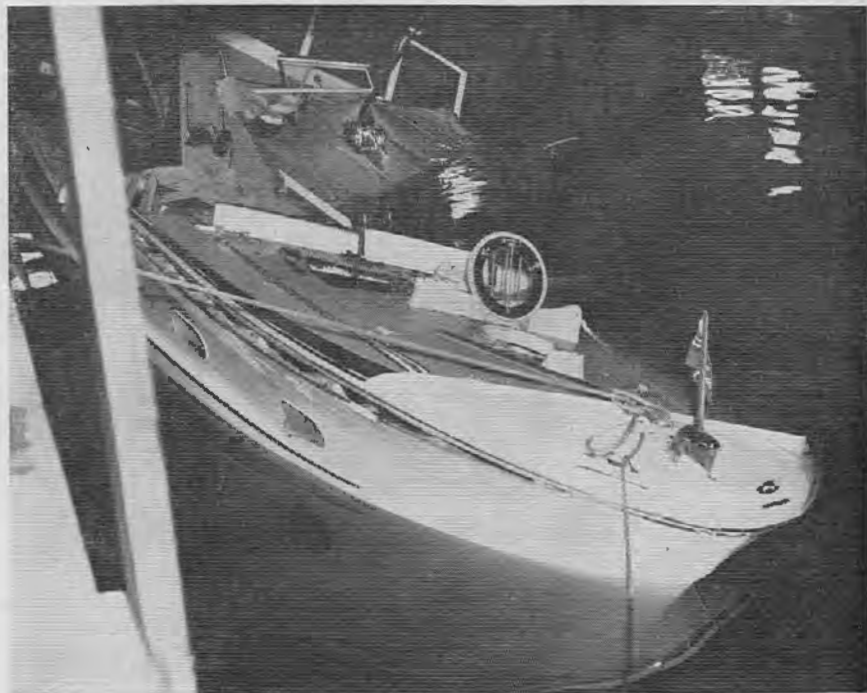
Figure 1

A sleek modern cabin cruiser was completely shattered and destroyed by a gasoline vapor explosion this Spring when an examination of the boat failed to disclose one important factor—tightness of the fuel tanks. See figure 1.

Both gasoline fuel tanks were recovered. Upon examination, they were found to be badly corroded, with numerous pin holes in the top and bottom of the tanks.

Early this Spring the man who served as the operator of the cruiser took her out of storage and prepared her for the forthcoming cruising season. He cleaned, varnished, painted, repaired, and overhauled everything he thought necessary, and on the afternoon before the fateful day the cruiser was in apparently beautiful shape. However, one disastrous flaw had been overlooked. There were several pinpoint holes in the gasoline fuel tanks.

Beyond doubt, gasoline had leaked out of the defective fuel tanks during the period after the operator secured his vessel, and gasoline vapors accumulated in the interior of the cruiser during the night. Since there was no apparent source of ignition on board this vessel, other than the electrical equipment, it is quite apparent that the ignition of the gasoline-air mixture took place when one of the controls to the refrigerator compressor or the battery charger emitted an electrical spark.

As the cruiser was less than seven years old, it is difficult to see how properly constructed steel fuel tanks such as could be expected on an expensive cruiser of this type would deteriorate in this short period to the extent where gasoline would actually run out, but that is what apparently happened.

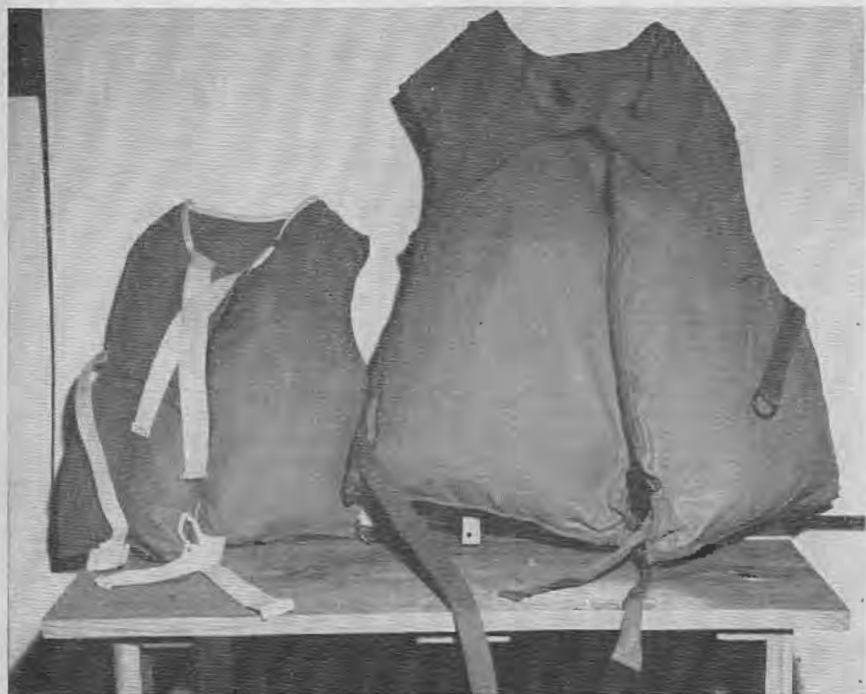
FIGURE 2 illustrates two typical approved jacket-type life preservers. Each approved jacket-type preserver must be stamped ADULT or CHILD, as the case may be, and in addition with the Model No., Manufacturer's Name and Address, Coast Guard approval number, and that it has been PASSED by the inspector.
