# *Proceedings*

*of the Marine Safety Council*

*September-October, 1993*

**Special issue on fire protection**

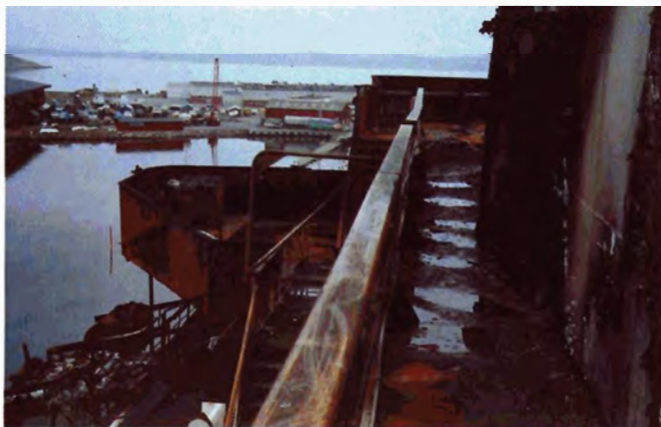
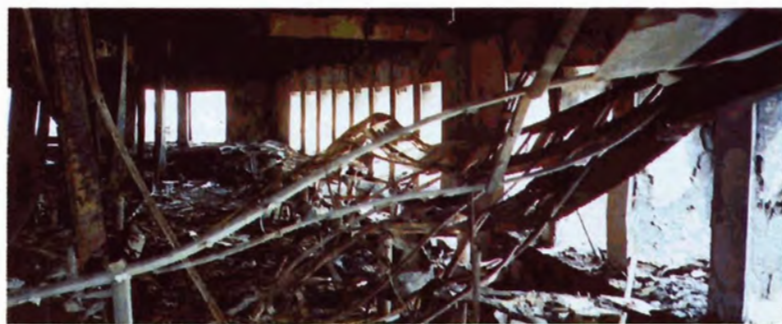
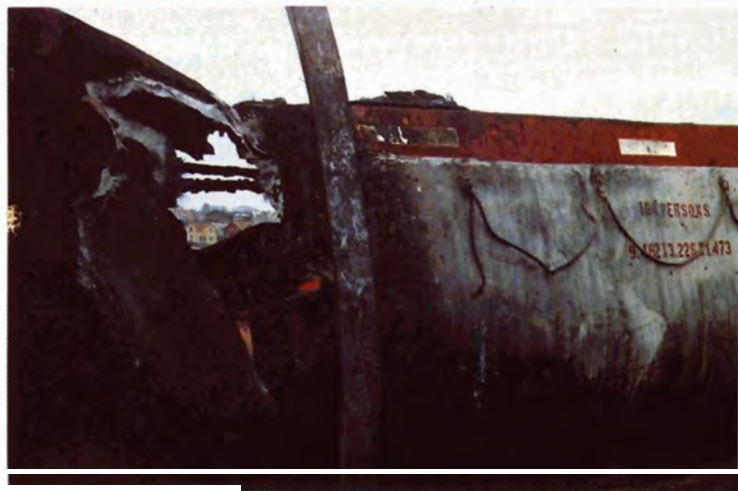
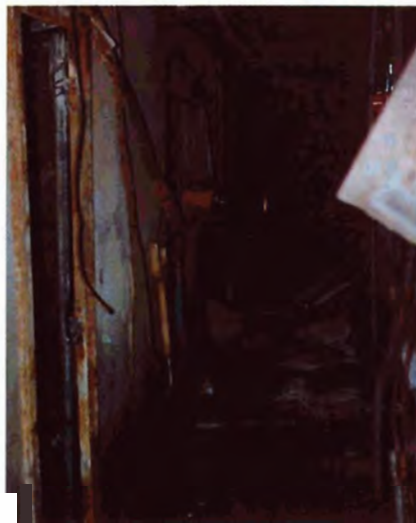
*Damages caused by fire on the passenger ship  
Scandinavian Star in April 1990.*

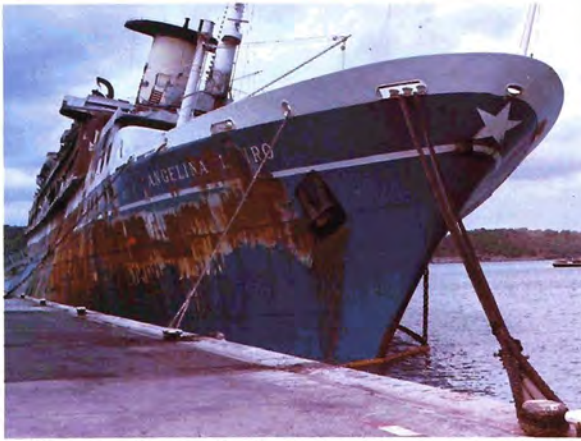
*The ship Angelina Lauro was almost destroyed by a fire, which started in the crew galley on March 30, 1979, while it was docked at St. Thomas in the Caribbean.*

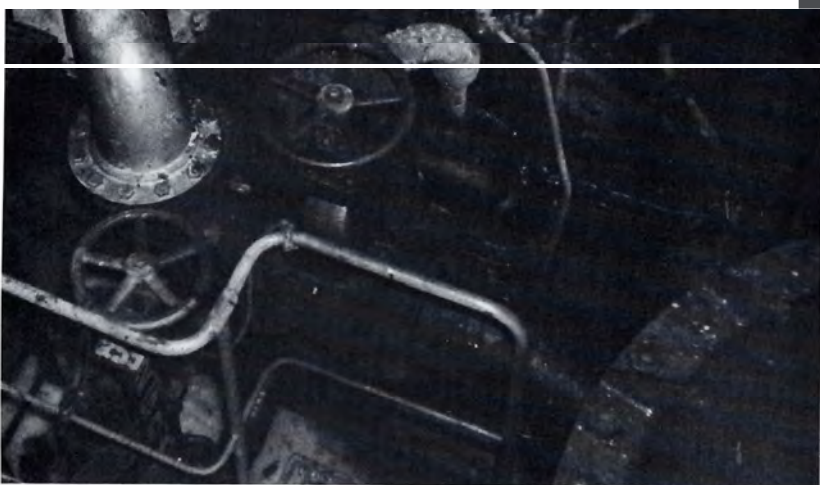
(Left) At the 2 o'clock position, the small valve is white from heat. This is the source of fuel. (Below) A similar valve shows epoxy bedding at its base, compensating for undersize threads.

About a week later, the photographs reveal that another identical unaffected pump in the same space had repairs at the bottom of a valve corresponding to the "hotspot valve" on the #1 pump. Epoxy putty had been used as a filler between the valve threads and the pump casing.

the Coast Guard investigator's theory. The base of the valve on the #1 pump casing had received repairs similar to those of the unaffected pump. As the pump casing was warmed by the flow of the preheated oil, a small leak developed at the base of the valve. Under pressure from the pump, an oily mist sprayed from this base.

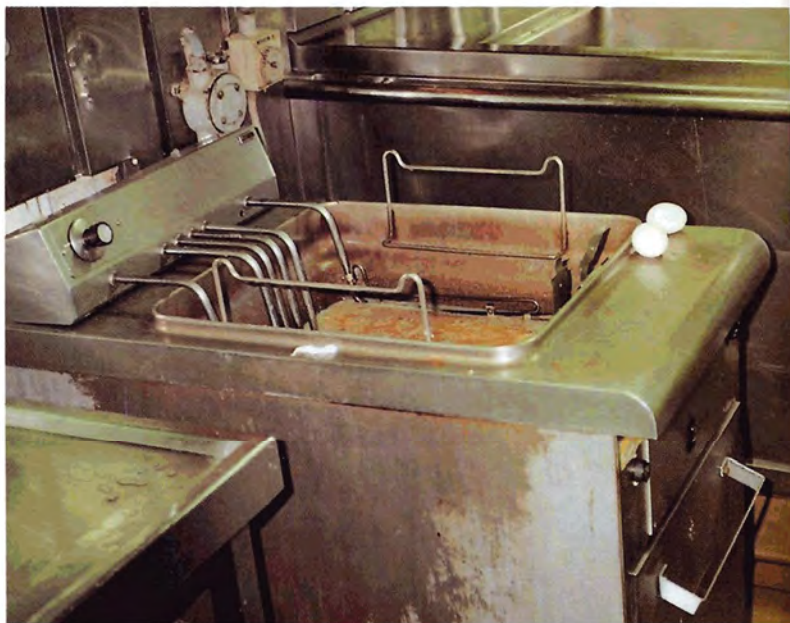
*(Above right) Deep fat fryer.*

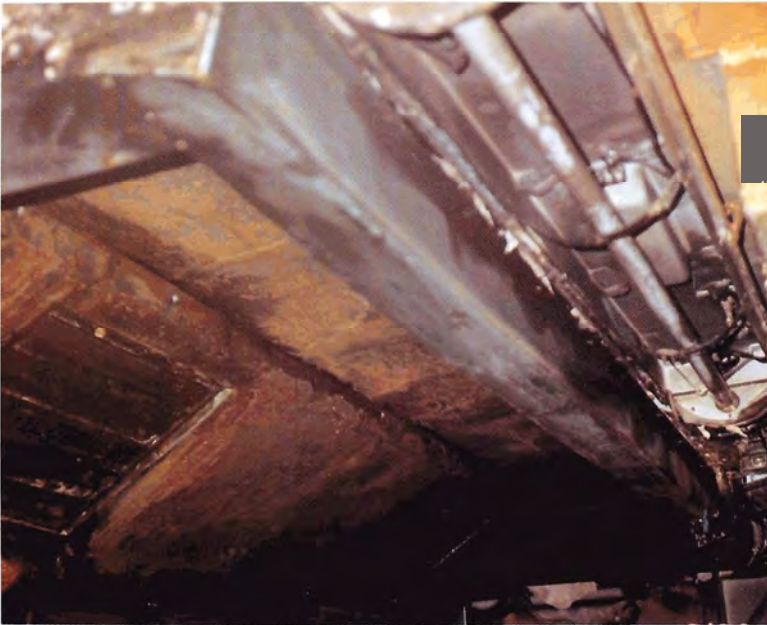
*(Bottom left) Back-to-back deep fat fryers.*

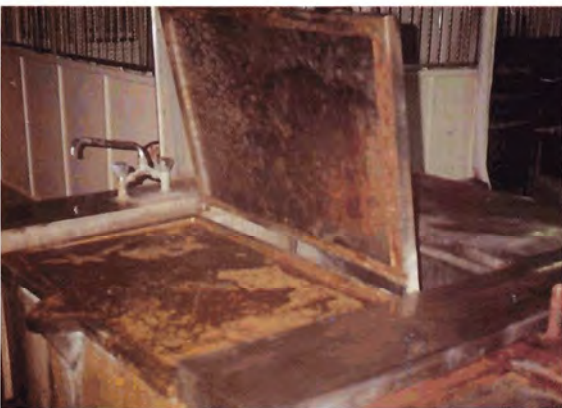
*(Below) Galley exhaust duct with access open.*

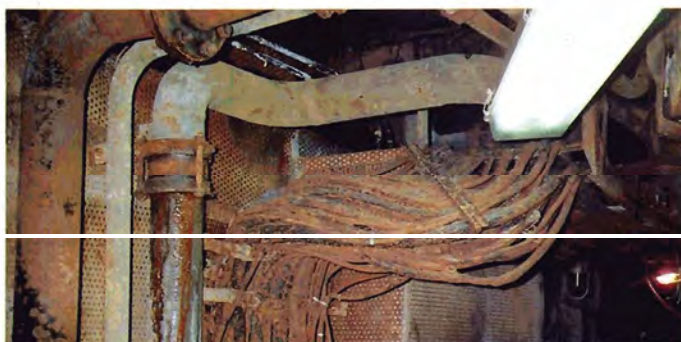
The #4 fan room sustained the most damage. A class A fire broke out on a metal storage shelf containing vent filters that burned very hot. The shelves warped and collapsed, and a duct above also warped. Some wire cable runs were destroyed in this space, affecting other vessel systems.

*Starboard cable tray.*

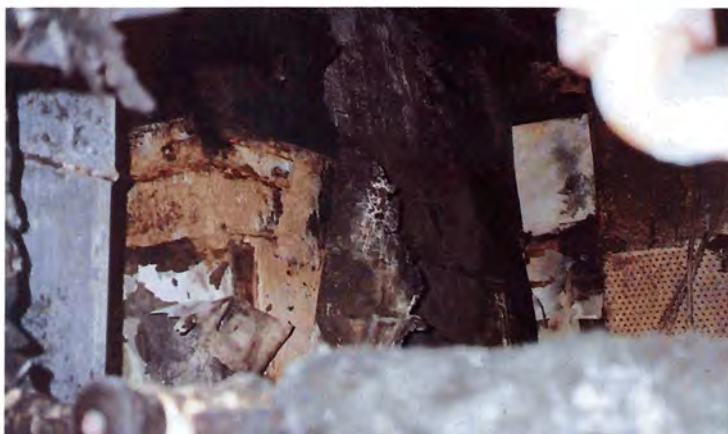
## *Fan room #14*

*Burnt insulation.*
