**REPORT OF THE INVESTIGATION
INTO THE
SCHOONER GRACE BAILEY (085754) DEMASTING
WITH THE LOSS OF ONE LIFE AND FIVE PASSENGER
INJURIES ON PENOBSCOT BAY, ROCKLAND, MAINE,
OCTOBER 9, 2023**

MISLE Activity Number: 7836612

**DISMASTING OF THE SMALL PASSENGER SAILING VESSEL GRACE BAILEY
(O.N. 085754) RESULTING IN THE LOSS OF ONE LIFE ON PENOBSCOT BAY
NEAR ROCKLAND, MAINE ON OCTOBER 9, 2023**

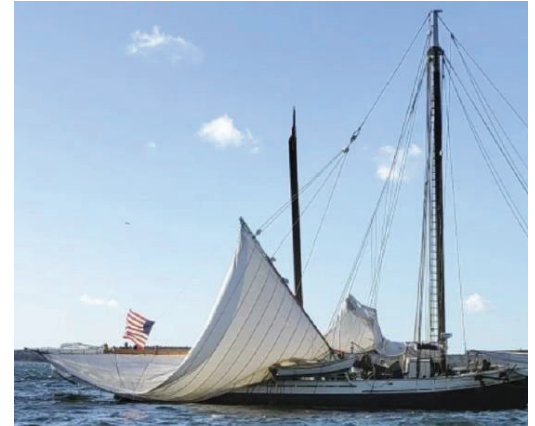
- 6.1.11. At 10:12 AM, a third noise reporting from aloft was recognized by multiple passengers and crewmembers. The captain and mate scanned the rig, finding the mainmast bending at a point approximately 75 percent up the mast. Without delay, the captain ordered everyone to get down. As he did, the mainmast collapsed, twisting, and falling to starboard.

Figure 4 - GRACE BAILEY from starboard after dismantling. (Maine Marine Patrol)

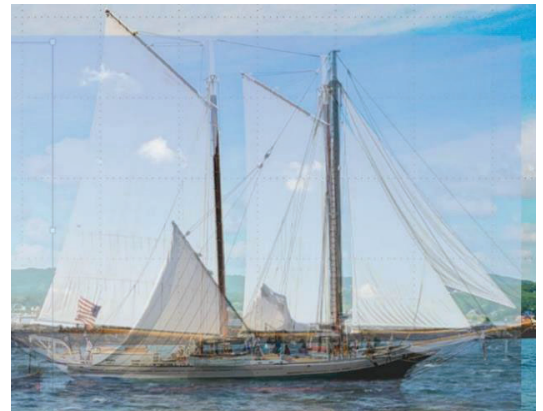
Figure 5 - GRACE BAILEY full sail arrangement over broken mast. (Source: USCG)

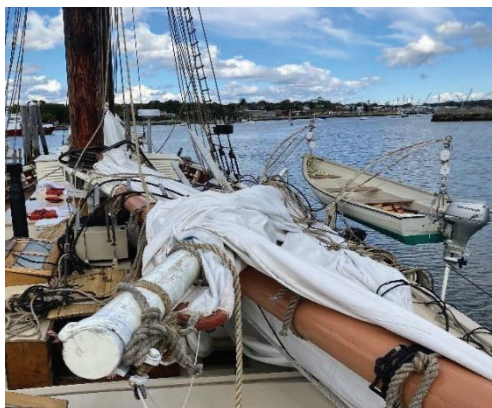
Figure 7 Main gaff resting atop the main boom. (Source: USCG)

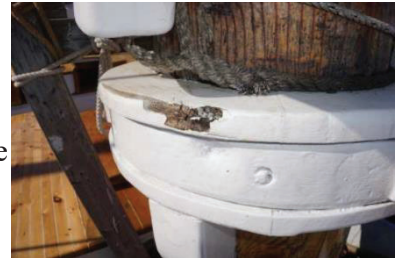
6.2.13.1. On May 5, 2022, the previous owner contracted an Insurance Survey of the vessel through a local marine surveyor. During this survey, the surveyor identified minor rot in the foremast boom saddle. No other conditions related to spars, sails, or rigging was found. The surveyor recommended the owner repair the rot in the foremast boom saddle as needed. Additionally, surveyor recommended the owner perform inspections as required by NVIC 02-16.

Figure 13 - Rot in foremast boom saddle found during survey, May 5, 2022, (Source: Maine Design report of survey)

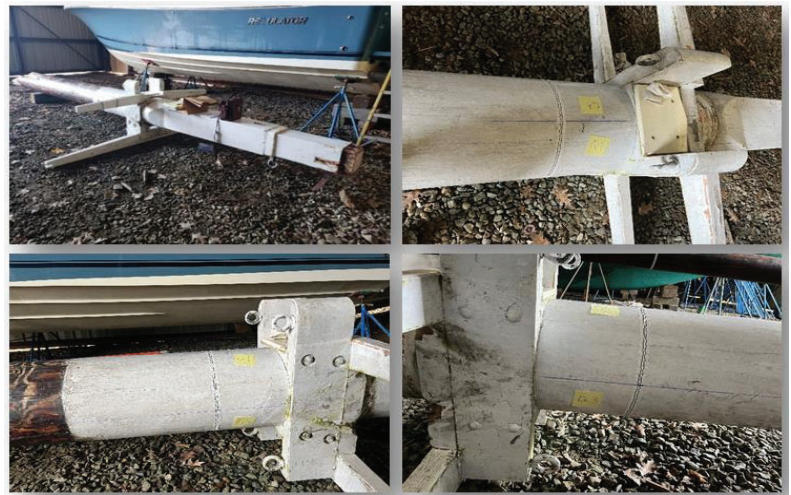
- 1.5. The exterior of the mainmast revealed no obvious external signs that would indicate rotted internal conditions. The mast was well coated with slush, smooth, and not discolored (lightening or darkening). Expected wear points in the vicinity of gaff jaw riding locations was noted. The installation of the trees was by way of compression around the mast, with no hardware penetrations into the mast (Figure 3).

Figure 3 - Upper mainmast/trees.

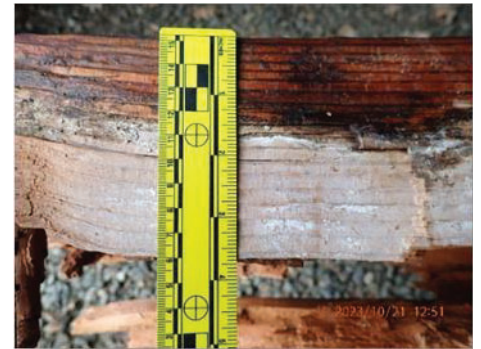
- 1.6. Growth rings well below six rings per inch, with some approaching $\frac{1}{4}$ inch (Figure 4) were noted. Internal material presented with cubicle fracturing (Figure 5).
- 1.7. Brash fracturing across growth rings, indicative of advanced decay, was observed across the entire mast cross section (Figure 5).
- 1.8. Hammer tapping of the entire length and circumference of the mainmast was conducted. This assessment identified suspect wood at 25 feet, 34 feet and 39 feet above the step. Probing and excavation at 25 feet and 34 feet revealed

Figure 4 – Deep check present at breakpoint depicting wide growth rings, inadequate penetration of slush, and remnants of mycelial matting.

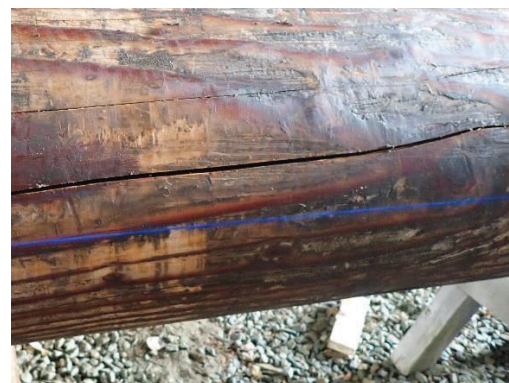
Figure 10 – Check Numbers 2.3 (46" length x ½" depth) and 2.4 (33" length x ½" depth). Probing did not reveal soft wood.

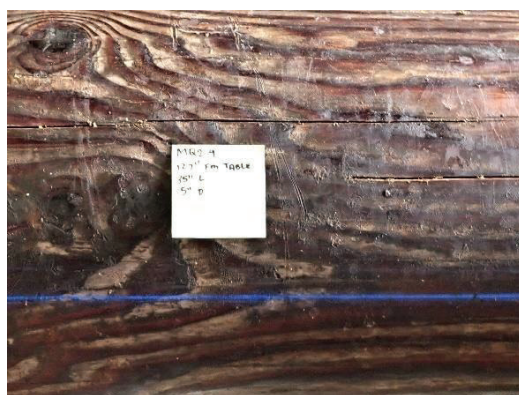
Figure 13 – Check Number 2.9(35" length x 1/2" depth). Probing did not reveal soft wood

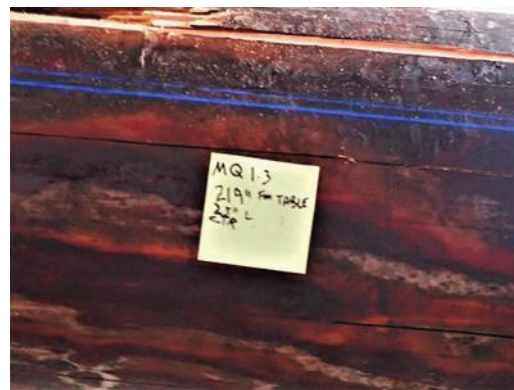
Figure 21 – Check Number 1.3 (23" length). Soft wood apparent with probing. Probe was able to penetrate into center without resistance.

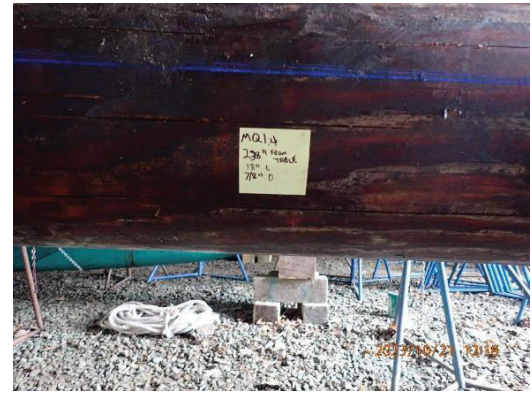
Figure 24 – Check Number 1.4 (18" length x ¾" depth). Probing did not reveal soft wood.

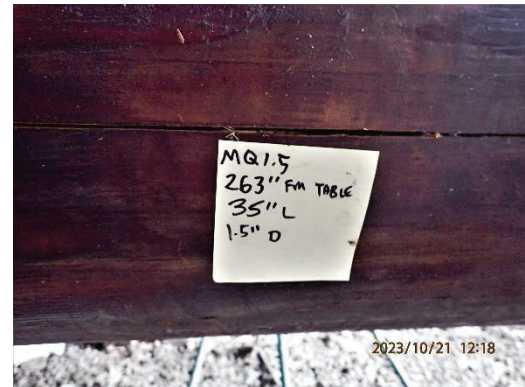
Figure 29 – Check Number 1.5 (35" length x 1 ½" depth). Probing did not reveal soft wood.

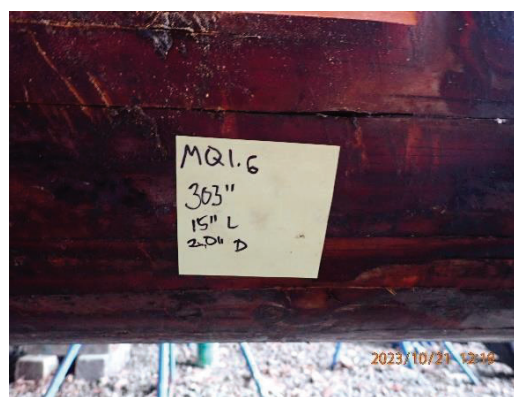
Figure 32 – Check Number 1.6 (15" length x 2" depth). Probing revealed soft wood.

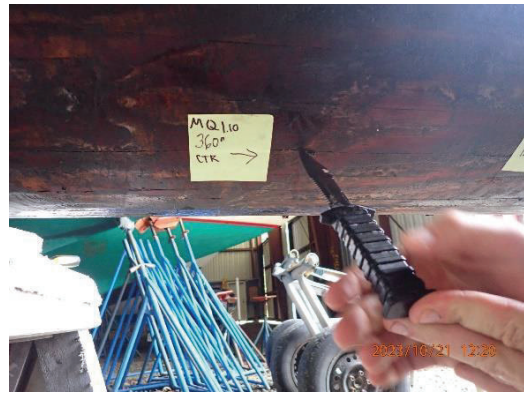
Figure 40 – Check Number 1.10 (18" length) Probing revealed soft wood, penetrating into the center without resistance.

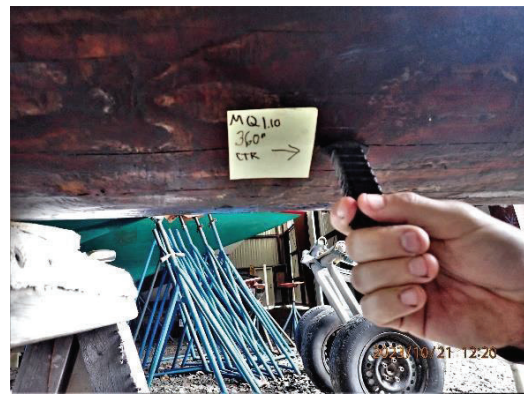
Figure 42 – Check Number 1.10 (18" length) Probing revealed soft wood, penetrating into the center heartwood without resistance.

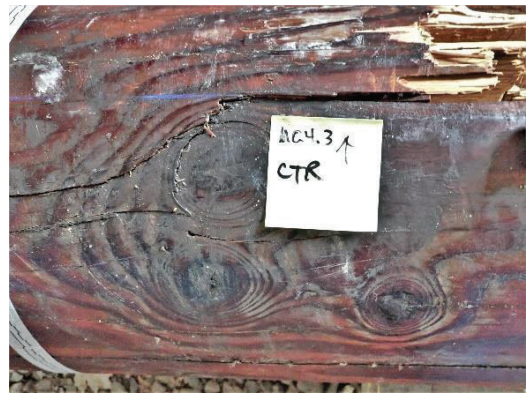
Figure 52 – Check Number 4.3 (57" length) Probing revealed soft wood, penetrating into the center without resistance.

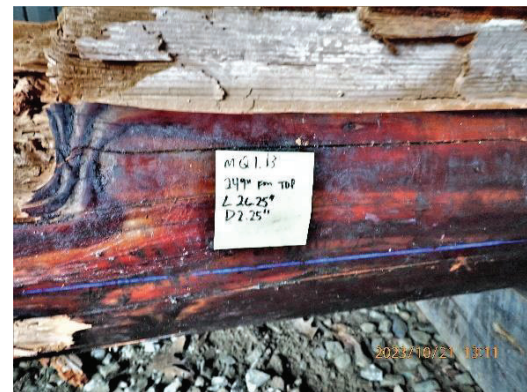
Figure 54 – Check Number 1.13 (26" length x 2 1/4" depth). Probing did not reveal soft wood.
